Final Report Project 3.5

A systematic and systemic review of mined landform stability and its impact on transitioning for regional benefits

February 2023

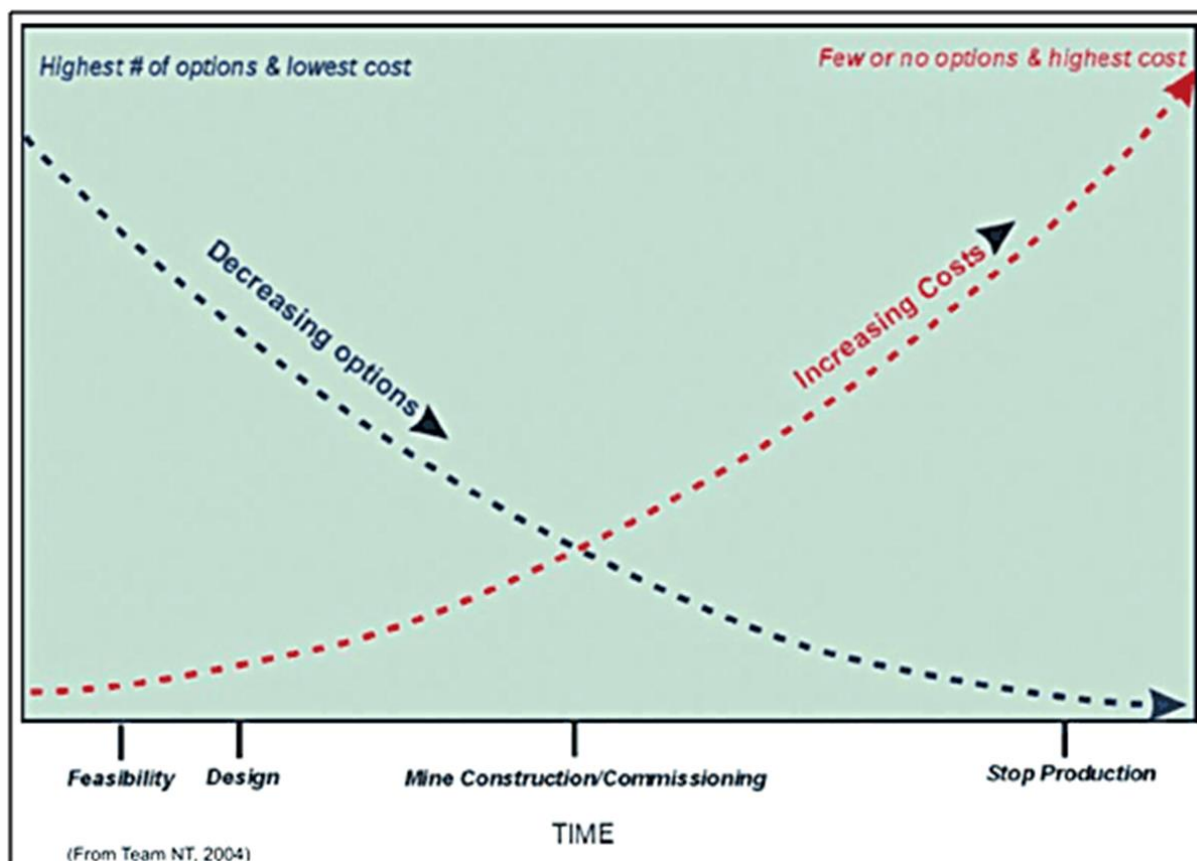
Figure 1: Closure options decrease and costs increase with time

According to the GARD Guide (2009), closure options decrease and costs increase with time (Figure 1), which is somewhat counter to NPV accounting with a high discount factor. Whole-of-life accounting is encouraged, if closure is to not only be effective, but also cost-effective.

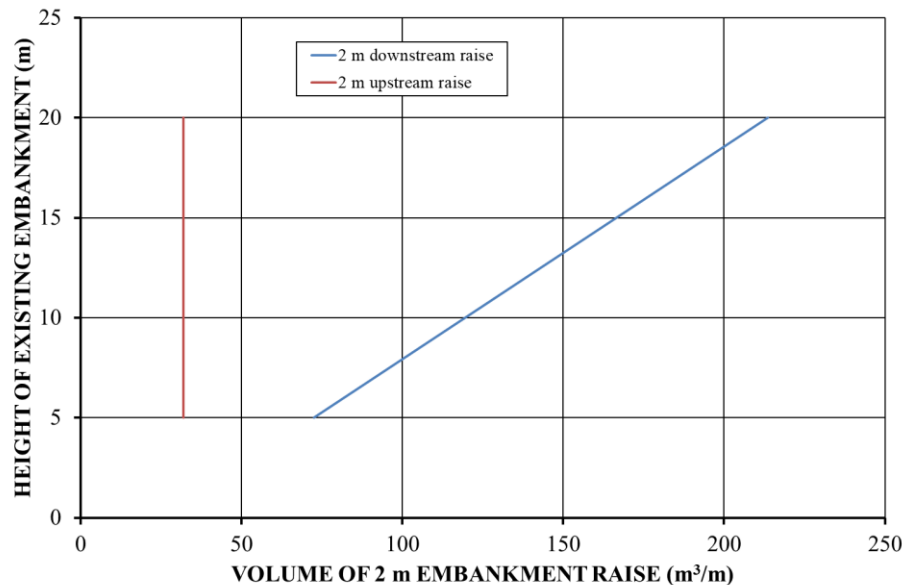
Figure 5: Relative fill volume requirement for upstream and downstream surface tailings embankment construction

Upstream construction is well-suited to dry climatic regions of Australia, and requires that the tailings be made a suitable foundation to support the next raise. This requires that the rate of rise of the tailings is limited to less than about 2m/year, that the tailings are deposited in thin lifts (of the order of 0.3m) and given sufficient time to consolidate and desiccate by exposure to sun and wind, and that water not be allowed to collect against the dam. It may be possible to use dried tailings to construct the majority of and upstream raise, with rip rap applied to the crest and downstream slope for erosion control. Downstream construction is more like a conventional water dam, although it requires substantially more fill than upstream construction (Figure 5).

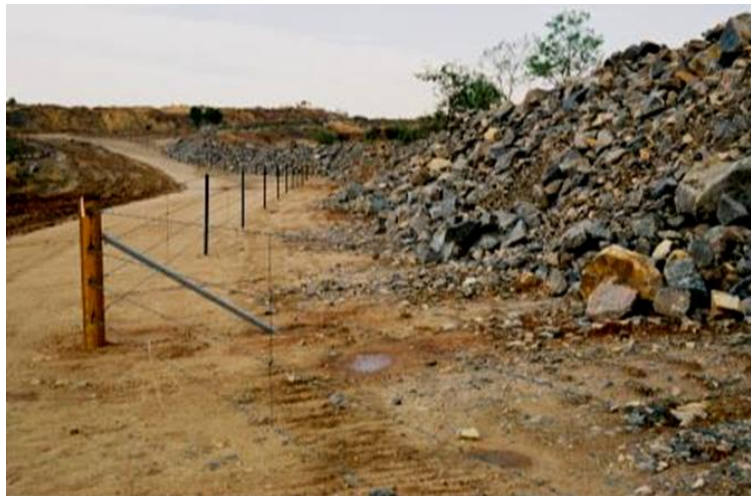
Figure 6: Bunding and fencing around crest of a closed open pit

The rehabilitation of open pits is often limited to bunding and fencing around the crest (Figure 6). In some cases, open pits are backfilled or converted to lakes (Figure 7). No block caves have been successfully rehabilitated, leaving an unstable subsidence zone (Figure 8).

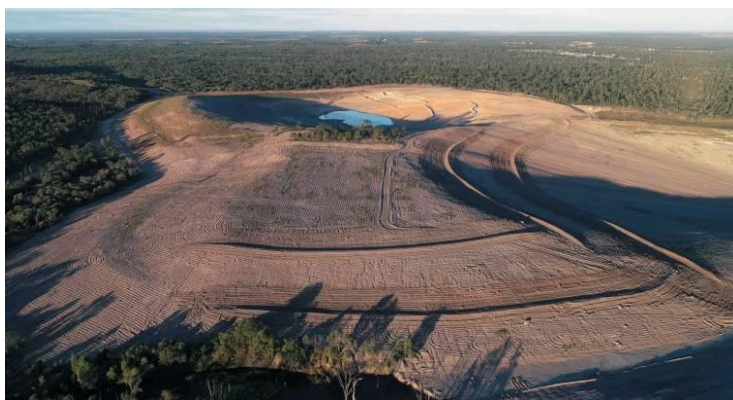
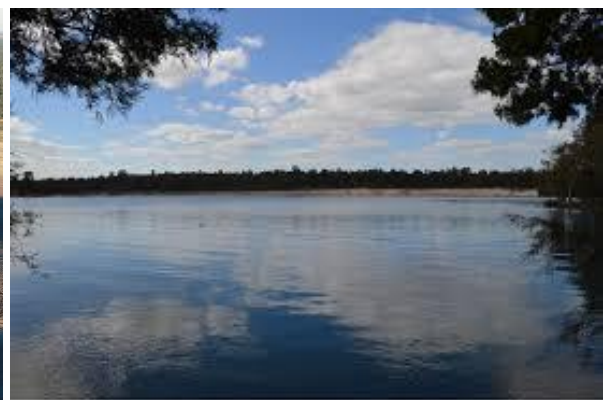
Figure 7: Open pit examples: (a) backfilling, and (b) flooding

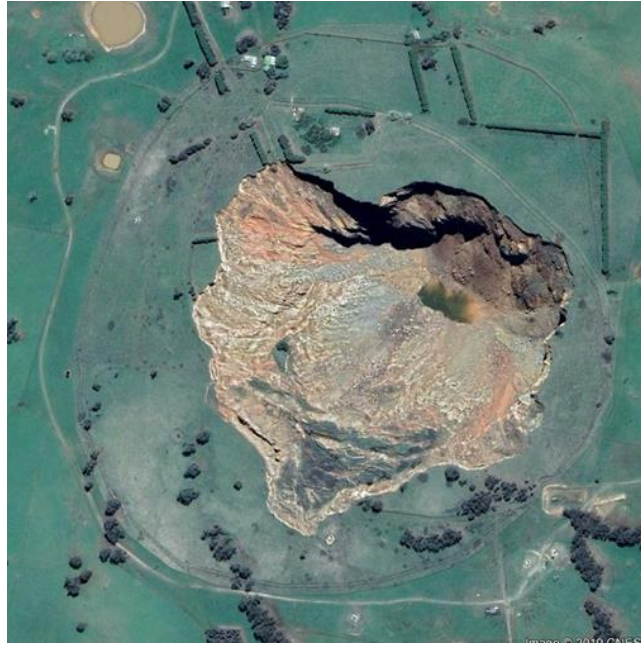
Figure 8: Unrehabilitated block cave

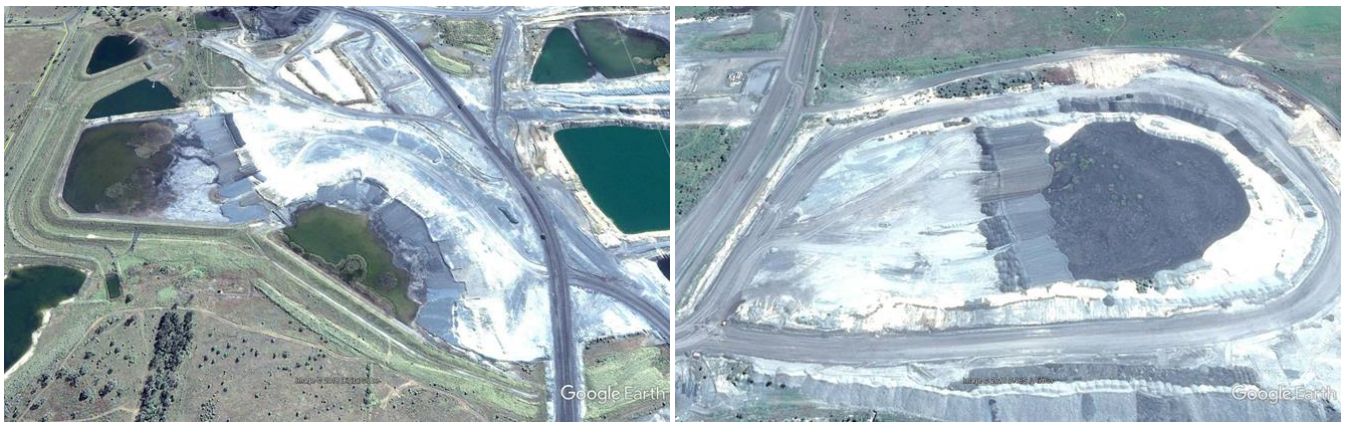
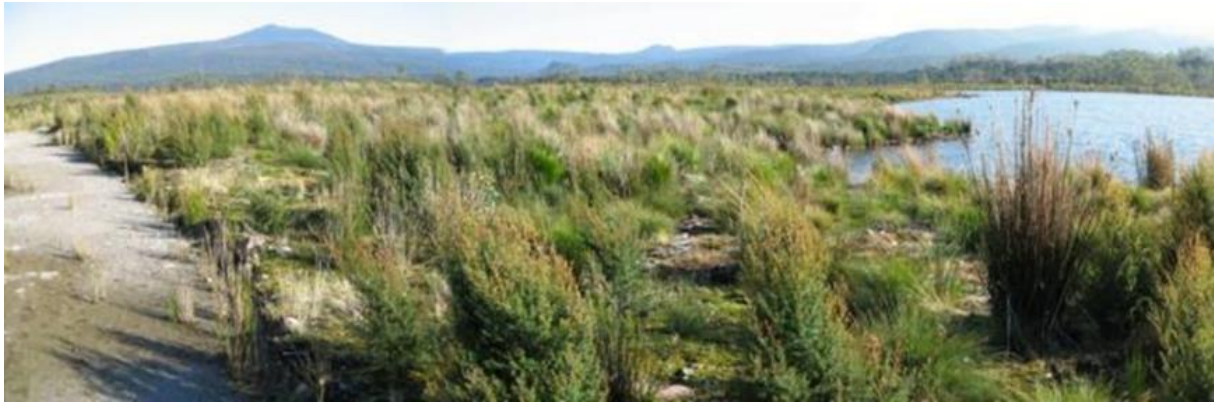
Figure 10: Successful rehabilitation of tailings facilities: (a) surface coal tailings, (b) in-pit coal tailings, and (c) sulfidic tailings in a cool, wet climate

Some tailings storage facilities, both surface and in-pit and in a range of climates, have been successfully rehabilitated (Figure 10; very few have been relinquished), with reprocessing and in-pit disposal increasingly being considered to remove the surface tailings facility and avoid the difficulties and cost of its rehabilitation.

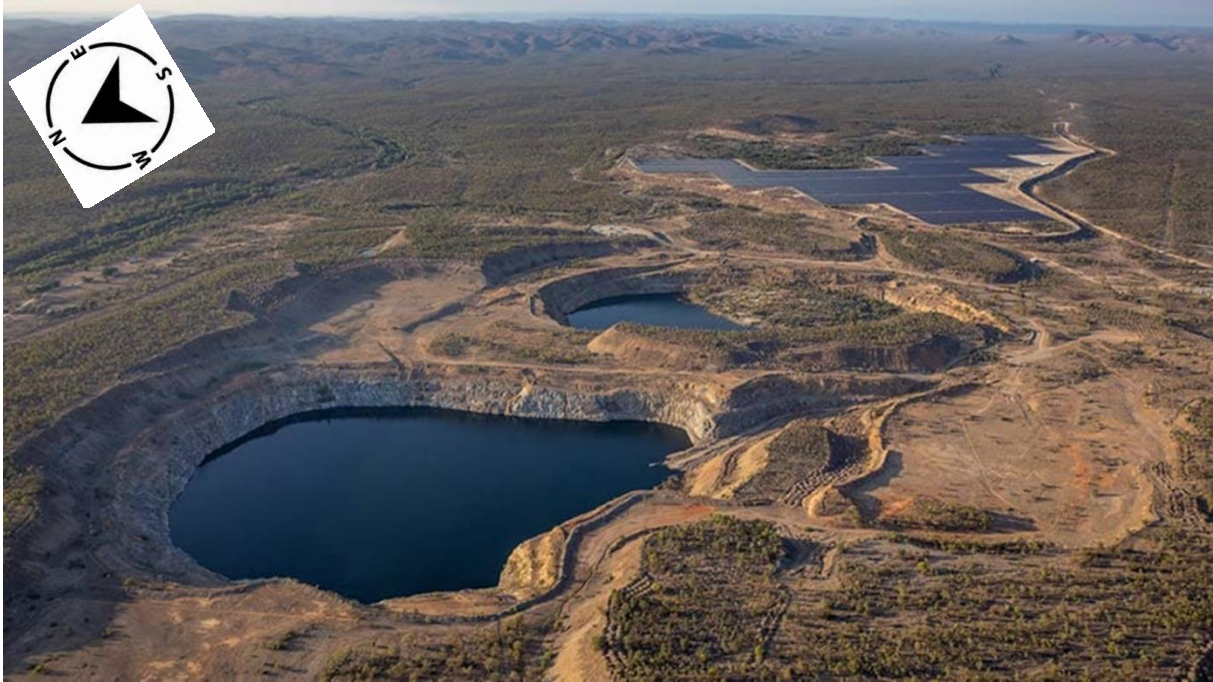
Figure 12: Aerial view of Kidston Genex site

Figure 12 shows an aerial view of the Kidston Genex site, with the Solar Farm on the surface tailings storage facility to the top left, and the two partially flooded open pits that will be converted into a Pumped Storage Hydro Project; the backfilled Wisers Hill Pit in the centre surrounded by the waste rock dump, and Eldridge Pit to the lower left of Figure 12.

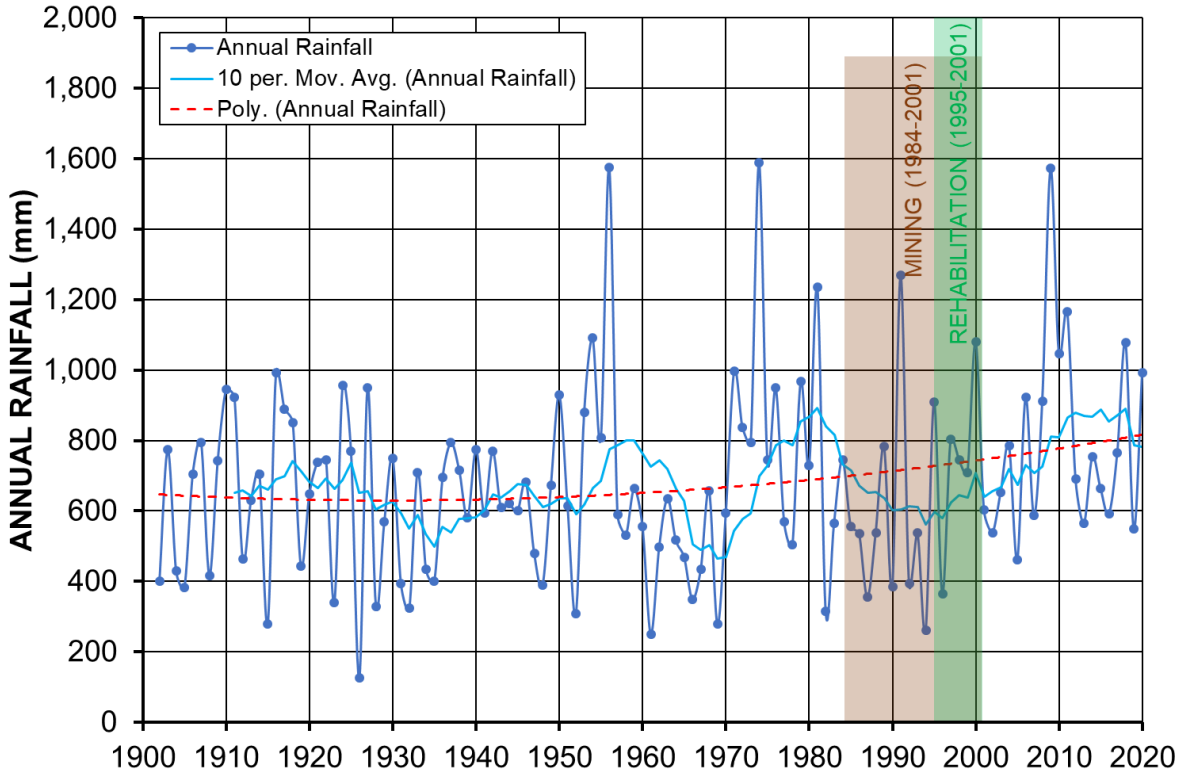
Figure 13: Long-term rainfall data representative of Kidston

The Kidston Genex site experiences a sub-tropical hot and humid wet season (December to March) and long cooler dry season (April to November; www.bom.gov.au). Figure 13 shows long-term rainfall data for the site since 1902, with the Kidston mining and rehabilitation timeframes overlain (mining from 1984 to 2001 and rehabilitation from 1995 to 2001). Figure 13 shows a rising trend in annual rainfall over time, from a low of about 620mm in 1940 to over 800mm in 2020. The historical mean annual rainfall is 656mm, and the range is from 126mm in 1926 to 1,588mm in 1974 (20 to 240% of the average). Since the rehabilitation and closure of Kidston Mine, the mean annual rainfall has been 795mm, with a range from 539mm in 2002 to 1,572mm in 2009 (68 to 198% of the average). Figure 14 shows the variation in monthly rainfall, including the average, lowest and highest monthly rainfalls recorded over the last 120 years. The average number of days of rain/year is 68 days, or only 19% of the year. The site climate is strongly net evaporative on average.

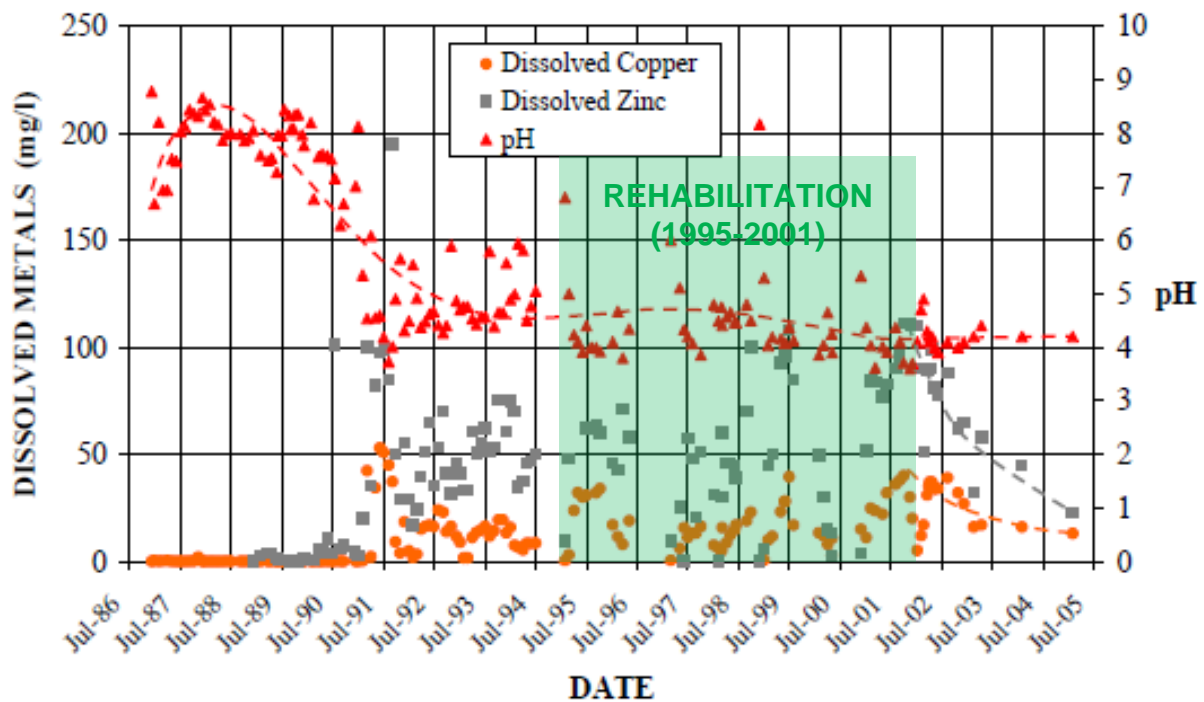
Figure 17: Improving seepage quality after completion of store and release covers

The pump-back of seepage from the surface waste rock dump toe seepage collection ponds to the pits provides an indicator of seepage rates from the facility, and increases with rainfall, although it will be somewhat lagged in time. Mean annual seepage from the waste rock dump is estimated from pumping records to be up to 2.2% of rainfall incident on the dump (at 1.8 L/s), allowing for evaporation from the seepage collection ponds of 0.3% of rainfall, and negating any seepage into the foundation. Of the 2.2% seepage, the uncovered side slopes account for an estimated 1.4% (assuming 50% rainfall infiltration), implying an estimated 0.8% net percolation through the store and release covers, which is as good as any cover would be expected to achieve.

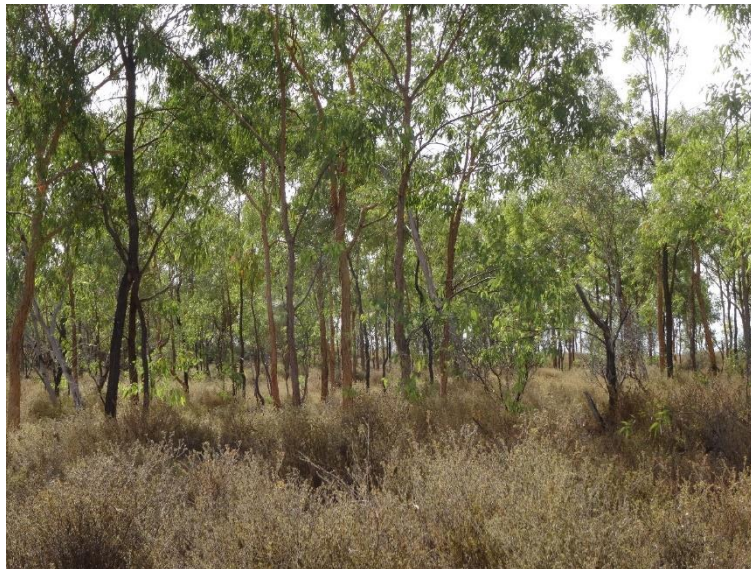
Figure 19: Good density and diversity of revegetation cover on waste rock dump

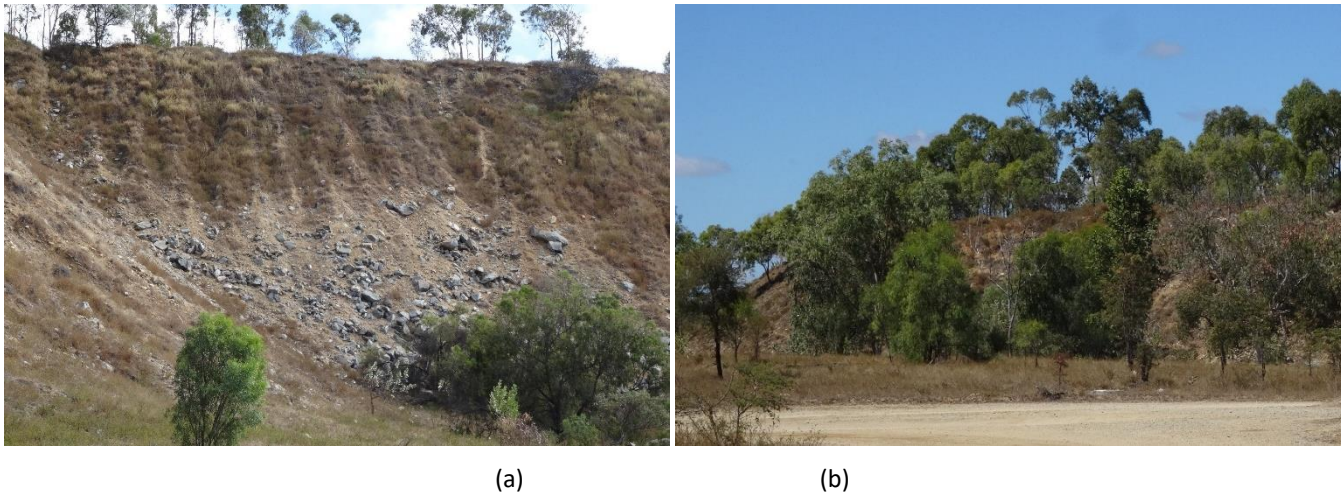
Figure 21: Variable dry season revegetation of side slope of waste rock dump: (a) grasses on limited oxide waste, and (b) well-treed oxide waste

Since the oxide waste was found to be highly erodible on slopes, the fresh barren waste rock side slopes of the waste rock dump were left at their angle of repose and partially over-dumped with oxide waste to promote moisture retention and revegetation (Figure 20). Recent dry season photographs of the side slopes of the waste rock dump are shown in Figure 21.

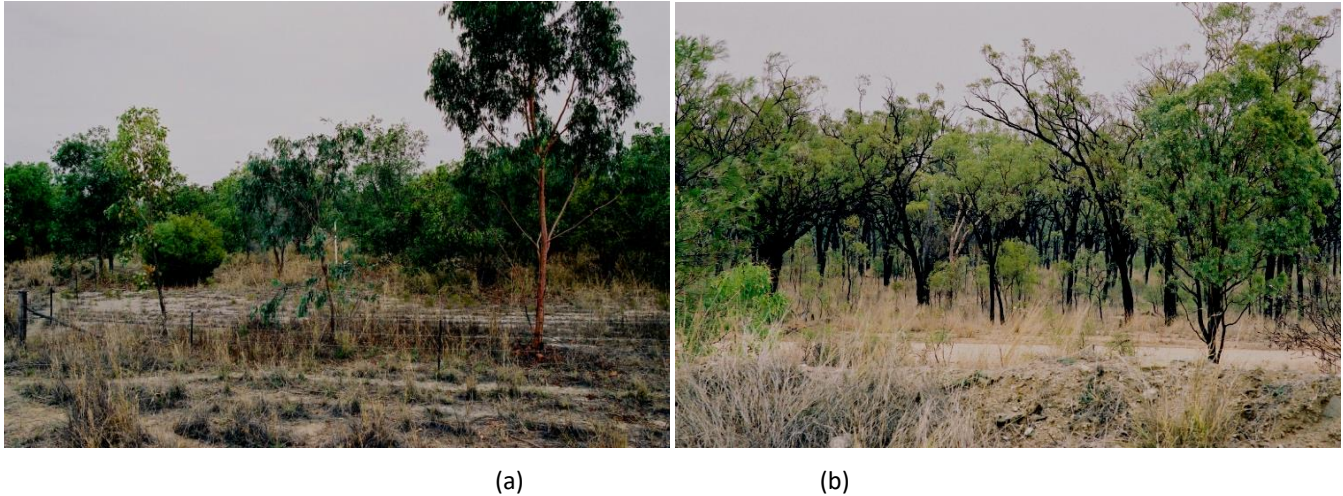
Figure 22: Revegetation on tailings (a) versus natural regeneration (b)

Mulligan et al. (2006) reported on direct revegetation trials on tailings from 1998, and monitoring of the direct revegetation of the tailings from 2001 to 2005, which demonstrated progression towards a sustainable native plant community, achieving almost 70% revegetation cover and less than 15% bare ground. There was more diversity of shrubs and trees on the revegetated tailings than in the surrounding grazed land, which had been subjected to periodic burning to promote pasture grass resulting in a dominance of ironbark trees (Figure 22).

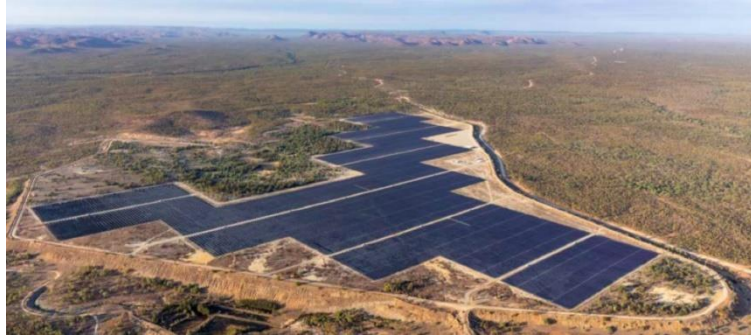
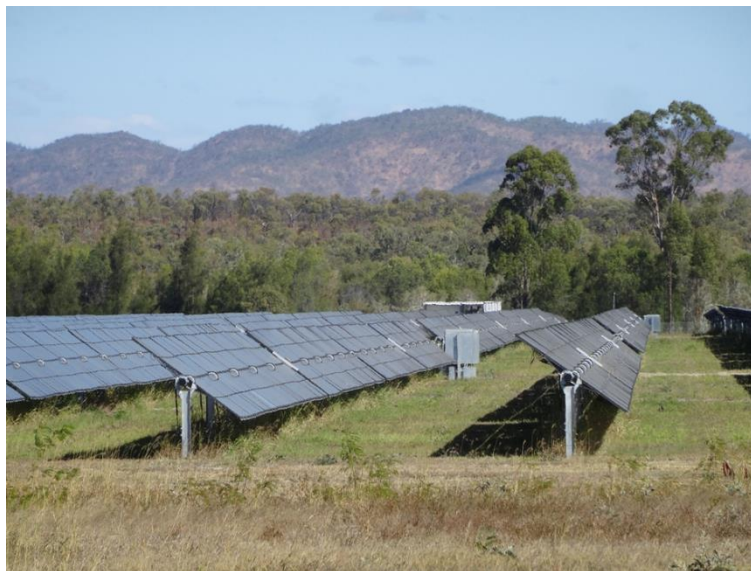
Figure 23: Genex Solar Farm on Kidston tailings storage facility: (a) aerial view, and (b) rotating solar panels and underlying grass and legume cover

In late 2017, Genex completed the construction of a 50 MW (AC, 63 MW DC) Solar Farm at a total cost of \$124 million, over a large part of the near-flat Kidston tailings storage facility. The project required the removal of trees and shrubs, while the original seeding and planting of high proportions of introduced grasses and legumes persists beneath the rotating solar panels, and is regularly slashed (Figure 23). The grasses and legumes control dust off the underlying tailings, continuing to satisfy this key rehabilitation requirement.

The project (<https://genexpower.com.au/50mw-kidston-solar-project>) has 540,000 solar panels operating on a single axis tracking system with an anticipated project life of 30 years, and takes advantage of the highest solar radiation zone in Australia. It feeds power to the National Electricity Market via the existing Ergon Energy 132 kV transmission line that previously fed power to the Kidston Mine. The project generates up to 145,000 MWh/year, powering up to 26,000 homes, and offsets up to 120,000 t of CO₂/year.

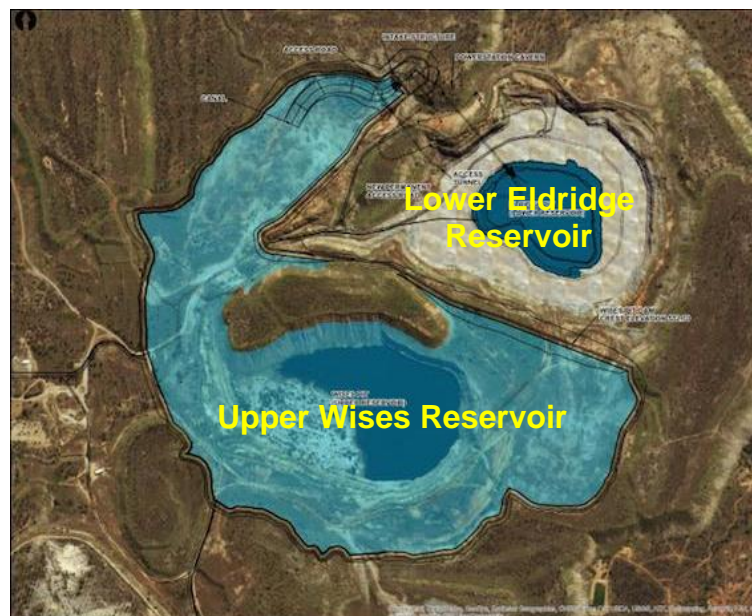
Figure 24: Plan view of Genex Pumped Storage Hydro Project at Kidston

The greatly enlarged Wises Pit storage will serve as the upper reservoir, and Eldridge Pit as the lower storage reservoir. The expansion of the upper reservoir is needed to maintain an adequate head above the turbines. The sides of the expanded Wises Pit will be lined with a geomembrane to limit seepage, while the underlying natural ground and pit walls are tight and of very low permeability. The nearby Copperfield Dam, which previously delivered water to the Kidston Mine and continues to supply water for local cattle grazing, will provide up to 30% make-up water to replace that lost to evaporation from the enlarged upper reservoir. The below-ground infrastructure of the Genex Pumped Storage Hydro Project at Kidston is shown in Figure 25 (AECOM, 2018).

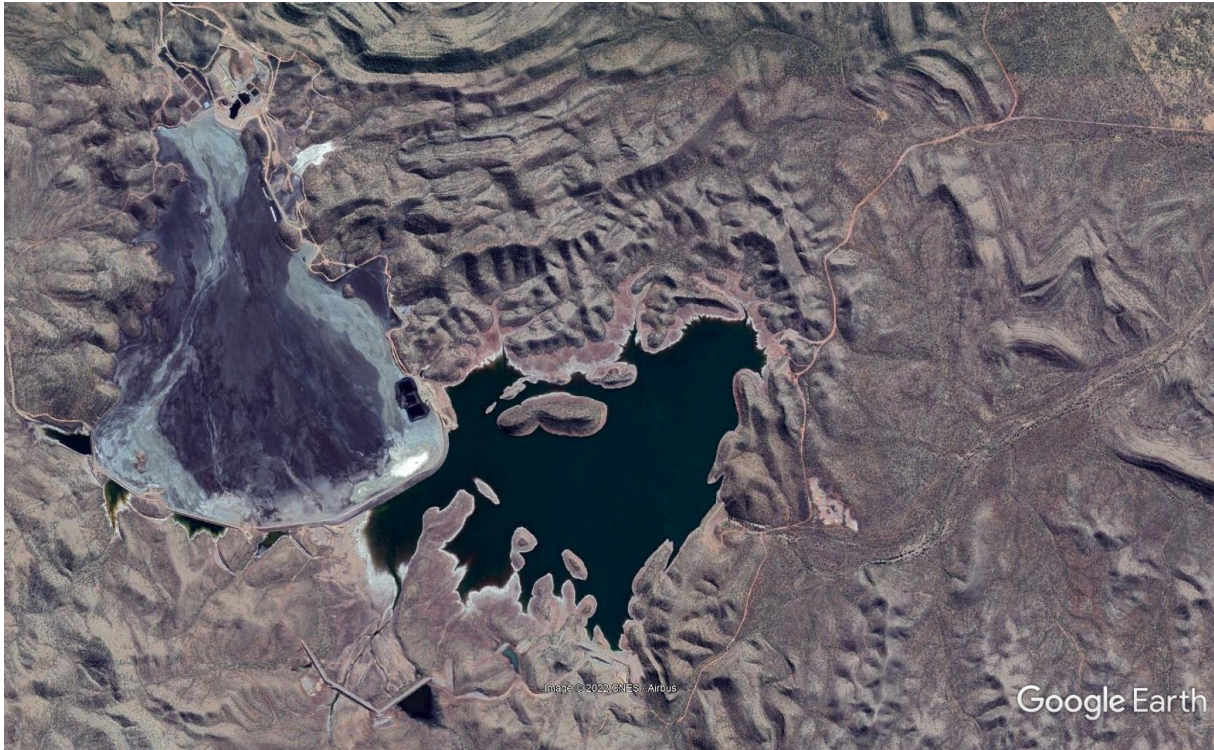
Figure 27: Google Earth image of Century Zinc Mine tailings storage facility (June 2018)

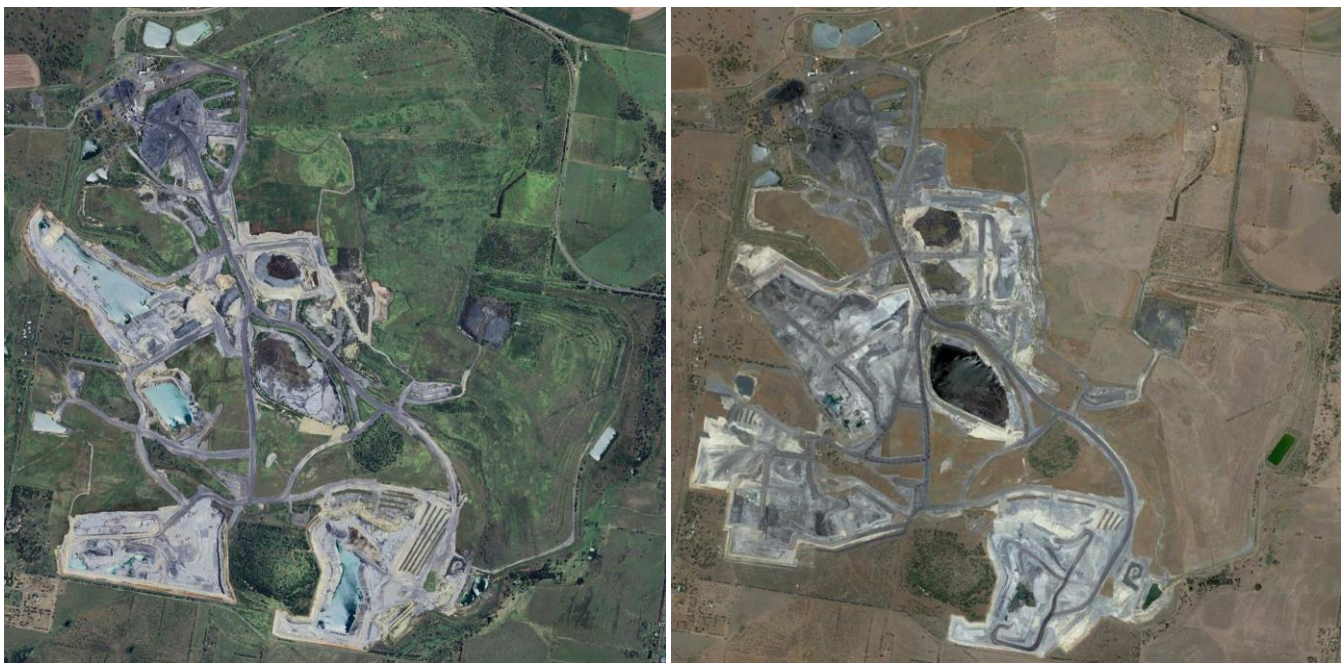
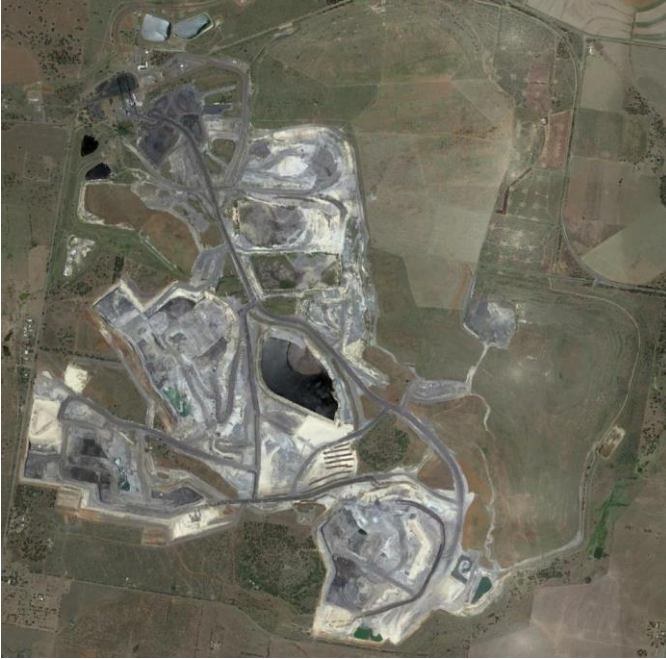
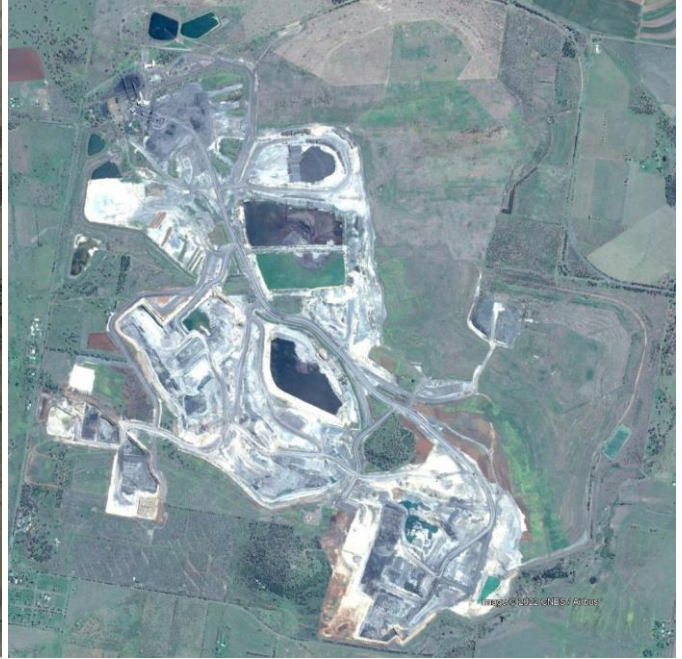
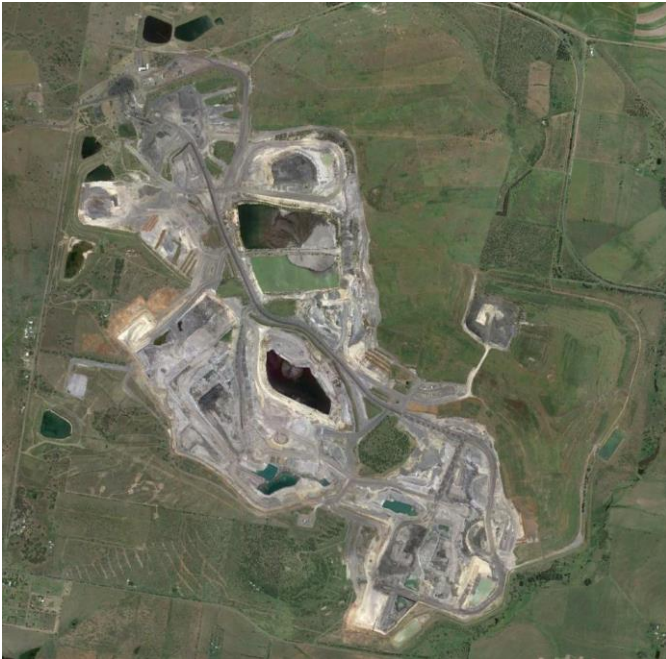
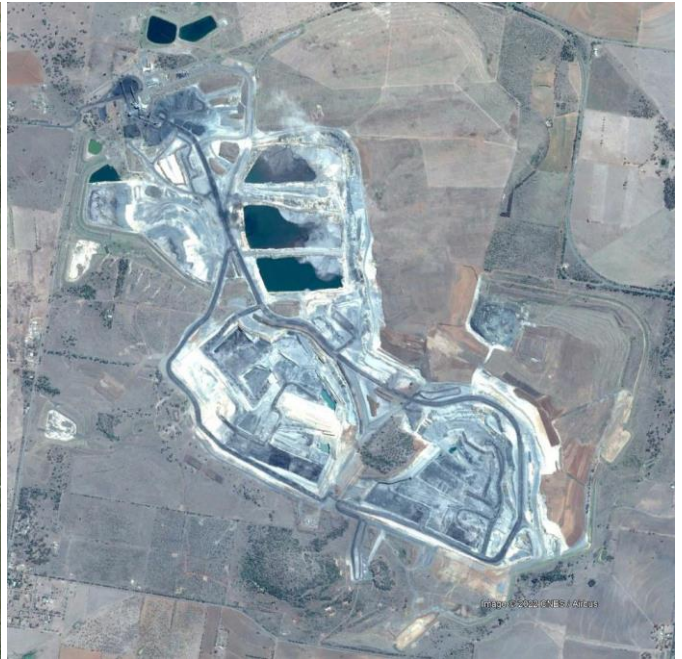
Figure 28: Google Earth images of New Acland Mine going back in time: (a) February 2022, (b) January 2019, (c) December 2017, (d) September 2016, (e) February 2016, (f) April 2013, (g) September 2009, and (h) February 2004

Figure 28 shows a series of Google Earth images of the New Acland Coal Mine going back in time. New Acland Coal Mine is located in the Walloon Coal Measures, about 10km north of Oakey on the Darling Downs of South-East Queensland. Mining is by open cut, and much of the pit is progressively backfilled with spoil as mining proceeds, as shown in Figure 28.

Figure 28 (g) also shows the surface tailings storage facility, which was capped and largely revegetated by December 2017 (as seen in Figure 28 (c)), and the first of four in-pit tailings storage facilities to the south, which were progressively capped and revegetated.

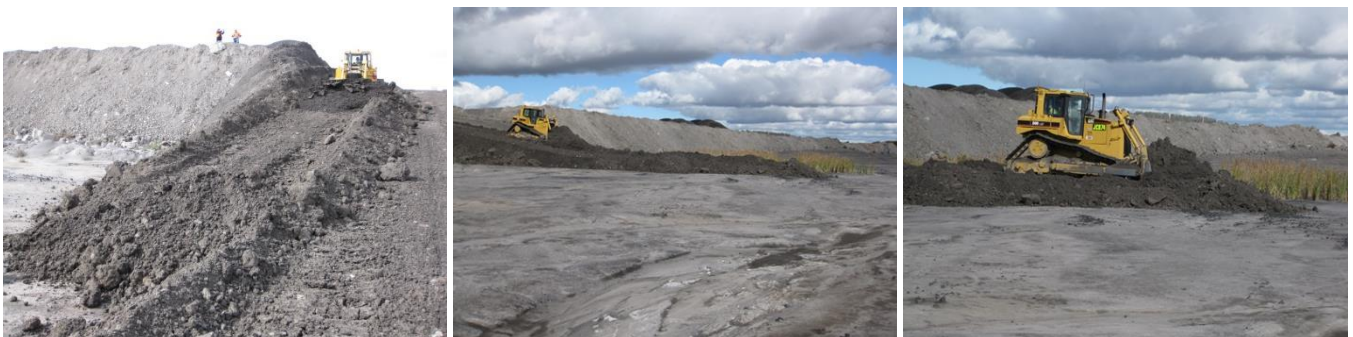
Figure 29: Start of pushing by D6 Swamp Dozer initial 1m thick capping layer of coarse reject over upper tailings beach

Capping of the New Acland surface tailings storage facility commenced in late 2009 and was completed and largely revegetated by December 2017. Figure 29 shows the start of pushing by D6 Swamp Dozer the initial 1m thick capping layer of coarse reject over the upper tailings beach. Figure 30 shows the observations of placing the initial capping layer, which were used to prevent bow-waving, and to safely direct the rate and advancement of initial capping. Placing the 1m thick initial capping led to a rise in the water table from about 1m depth to the surface, followed by hydraulic fracturing of the less permeable unsaturated surface crust to allow drainage from the more permeable saturated tailings at depth, and the initiation of bow-waving signaling the limit of safe capping at that location.

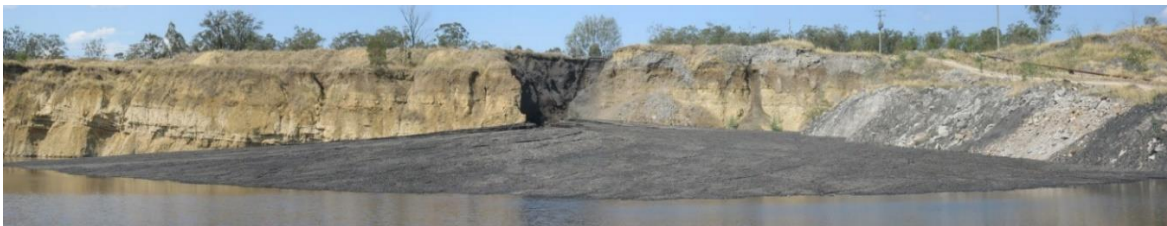
Figure 32: Capping wet and soft tailings, by: (a) hydraulic placement of coarse material, and (b) end-dumping of coarse material

Wet and soft tailings, such as those deposited in-pit, may be “capped” by hydraulic placement or by end-dumping of free-draining and durable coarse material. Hydraulic placement would involve the pumping of coarse materials such as coarse reject, forming a steep beach of about 1 vertically in 10 horizontally, and progressively moving the discharge pipeline out over the steep beach to complete the cover. Figure 32 (a) shows the coarse reject upper beach that forms on the pumped co-disposal of coal washery wastes (coarse reject and tailings). A similar steep beach would form if coarse reject only were pumped.

End-dumping of spoil or coarse material, such as waste rock, spoil or coarse reject, off a tip-head, could also form a cap over wet and soft in-pit tailings, as shown schematically in Figure 32 (b), similar to end-dumping in water. The coarse material would displace water and tailings solids within the mixing zone, loading the tailings below, with clean coarse material above. End-dumping could be progressed out from the tip-head. The shear strength profile with depth of tailings always maintained under water is zero at the tailings surface and increases linearly with depth at a rate dependent on the specific gravity of the tailings solids and the extent to which the tailings are fully normally-consolidated. For coal mine tailings with a specific gravity of less than 2.0, their normally-consolidated shear strength would increase with depth at a rate of about 0.8 kPa/m depth. For typical metalliferous tailings, with a specific gravity of 2.8, their normally-consolidated shear strength would increase with depth at a rate of about 1.2 kPa/m depth. This shear strength would provide some bearing capacity for the end-dumped coarse material, which would progress deeper into the tailings as more mass of coarse material is added.

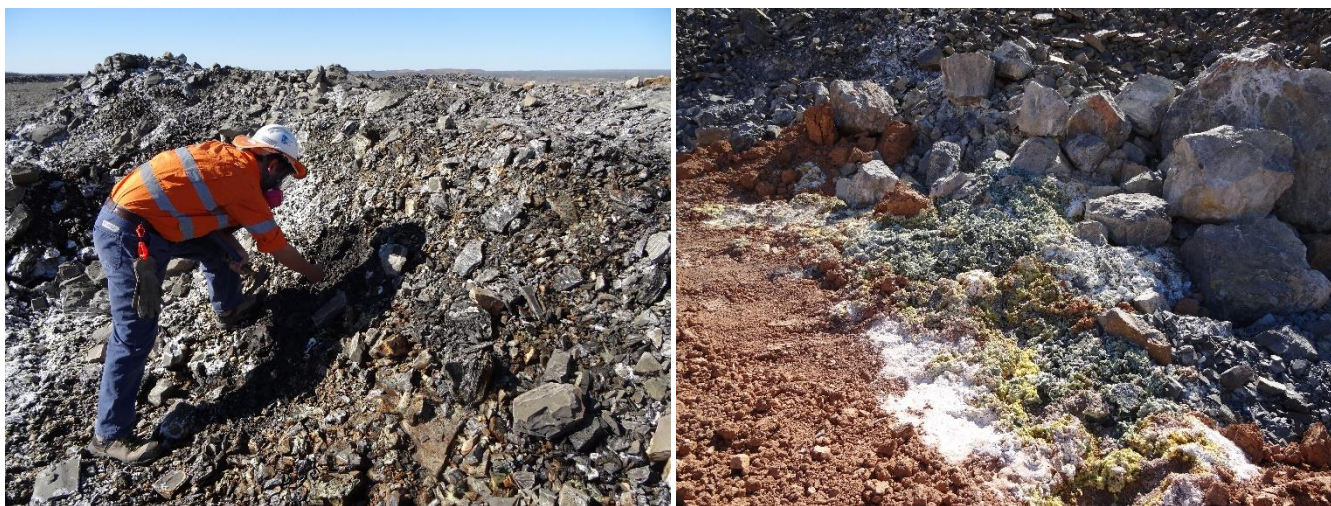
Figure 35: Oxidation of sulfidic waste rock exposed on the North Overburden Emplacement Facility

The North Overburden Emplacement Facility suffered from oxidation of sulfidic waste rock, leading to “spontaneous combustion” due to it being an exothermic reaction, the generation of noxious gases SO₂, CO and CO₂, and the production of acidic seepage from the facility, which was collected in lined ponds around the toe. Figure 35 to Figure 38 show photographs taken of the North Overburden Emplacement Facility in August 2015. Figure 35 shows examples of oxidation of potentially acid forming waste rock in the facility on exposure to oxygen and moisture.

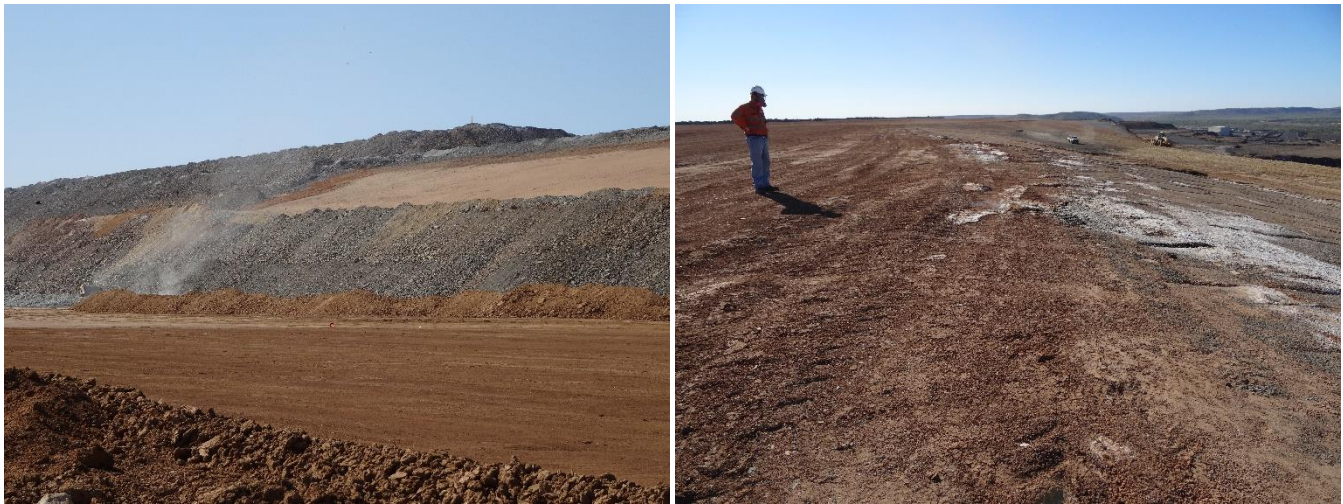
Figure 37: Capping flattened dump slopes with compacted clay to mitigate spontaneous combustion of underlying waste rock, showing: (a) flattening and capping of smoldering waste rock, and (b) breakthrough of a compacted clay layer

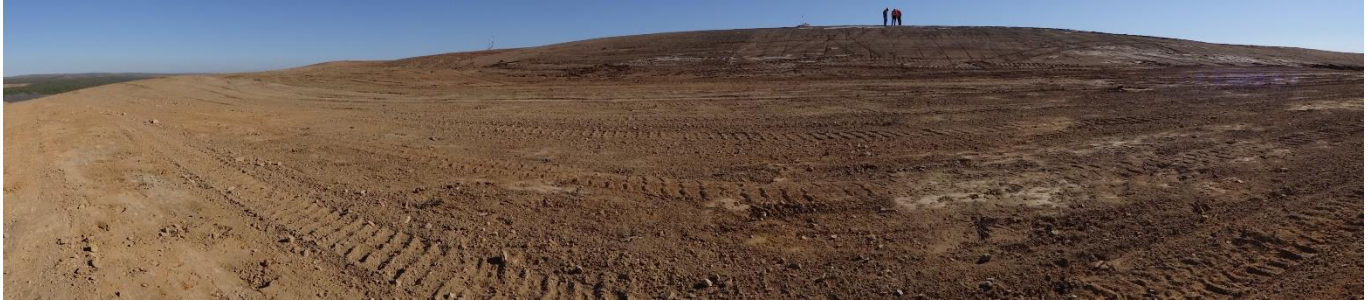
Figure 38: View of North Overburden Emplacement Facility, showing: (a) large-scale capping, and (b) view down to a seepage collection pond at toe

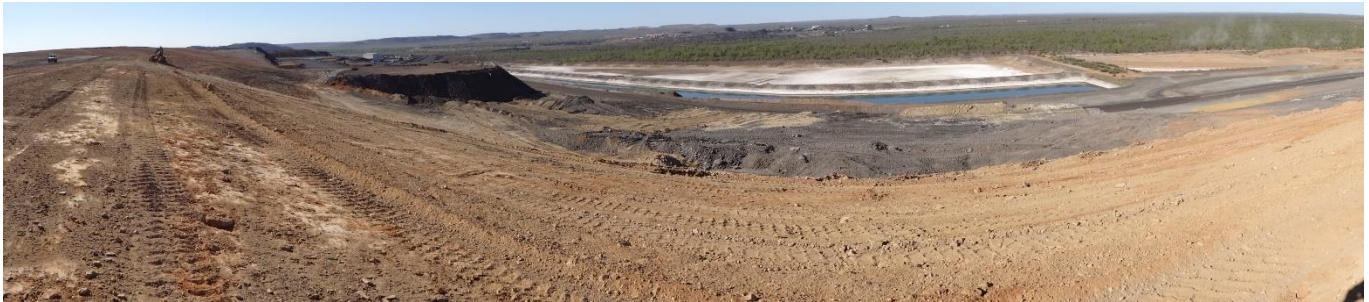
Figure 38 shows large-scale capping of the North Overburden Emplacement Facility, which again was only partially successful in reducing spontaneous combustion, and a view down to a seepage collection pond at the toe, and Figure 39 shows the view from the North Overburden Emplacement Facility towards the nearby culturally significant Barrumundi Dreaming landform.

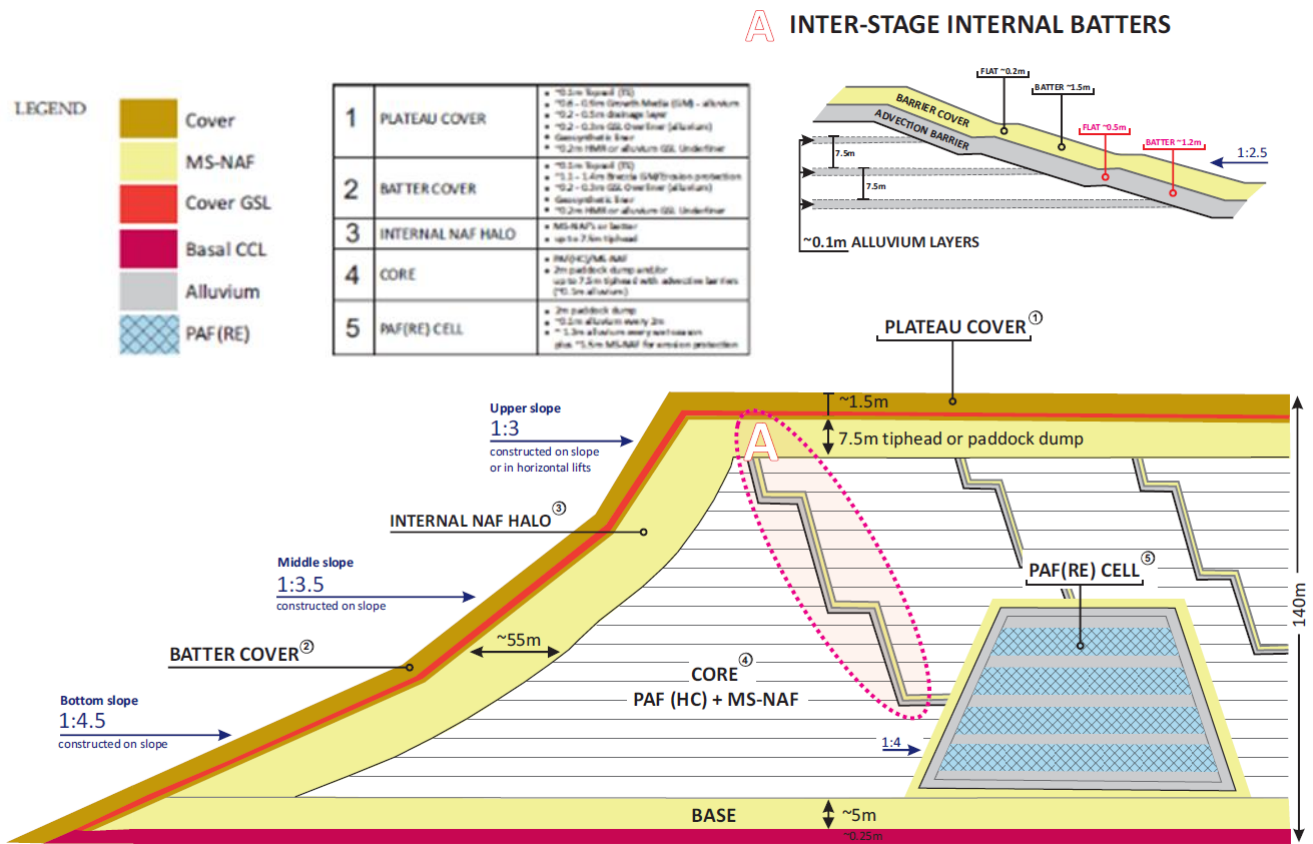
Figure 42: Revised North Overburden Emplacement Facility cross-section proposed in 2017

The 2012 cover strategy was revised in the 2017 Supplementary Environmental Impact Statement to that shown in Figure 42, with the most potentially acid-forming waste rock encapsulated well within the dump and, crucially, not located under the side slopes that are difficult to cap. The final slope profile was replaced with a concave shape that better matches natural slope profiles, driven by community expectations, and also reduces erosion.

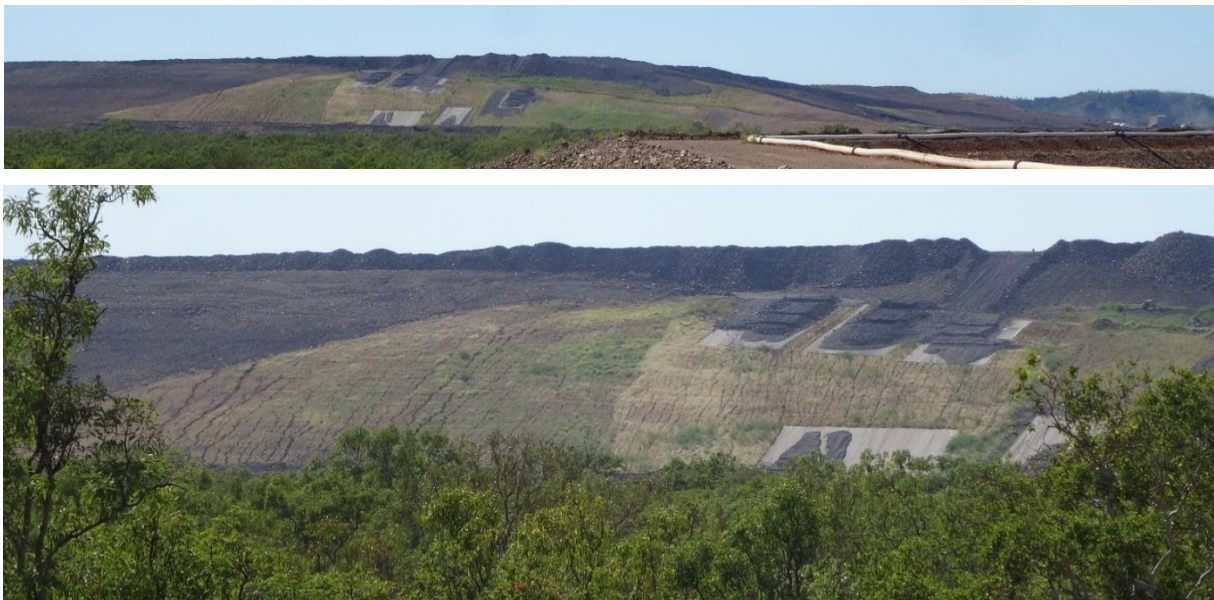
Figure 43: Progressive rehabilitation of North Overburden Emplacement Facility in accordance with Supplementary Environmental Impact Statement in April 2021

The progressive rehabilitation of the North Overburden Emplacement Facility in accordance with the Supplementary Environmental Impact Statement is shown in photographs taken in April 2021 in Figure 43.
