Final Report Project 3.5

A systematic and systemic review of mined landform stability and its impact on transitioning for regional benefits

February 2023

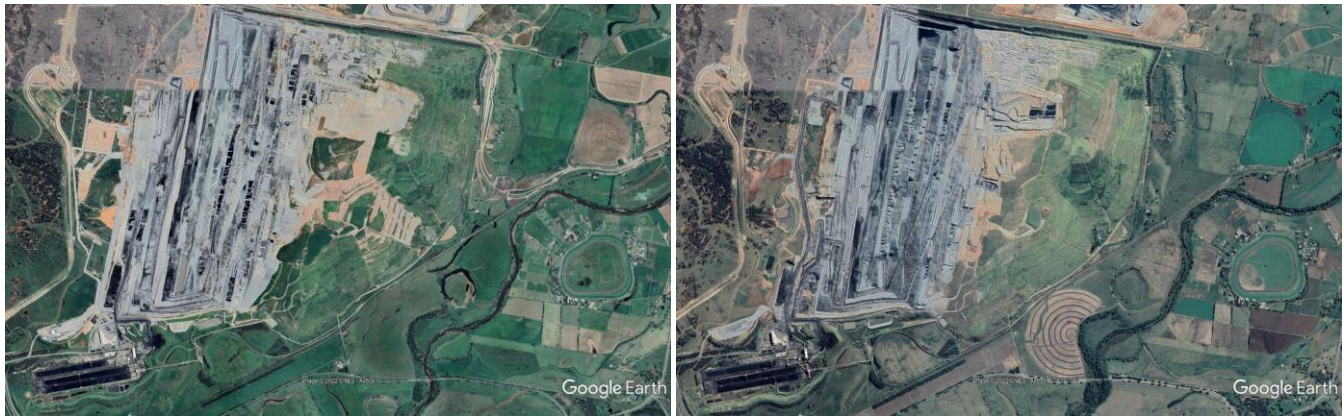
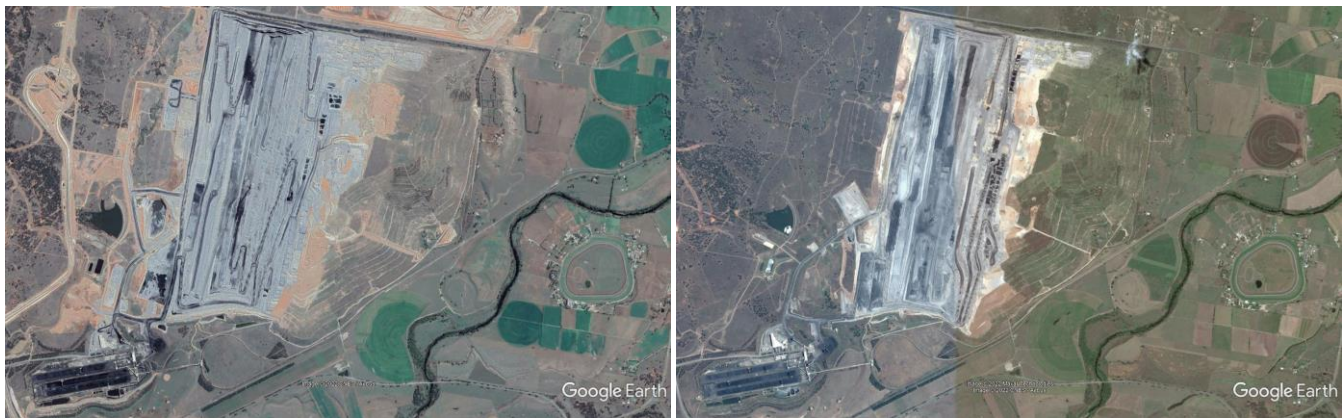
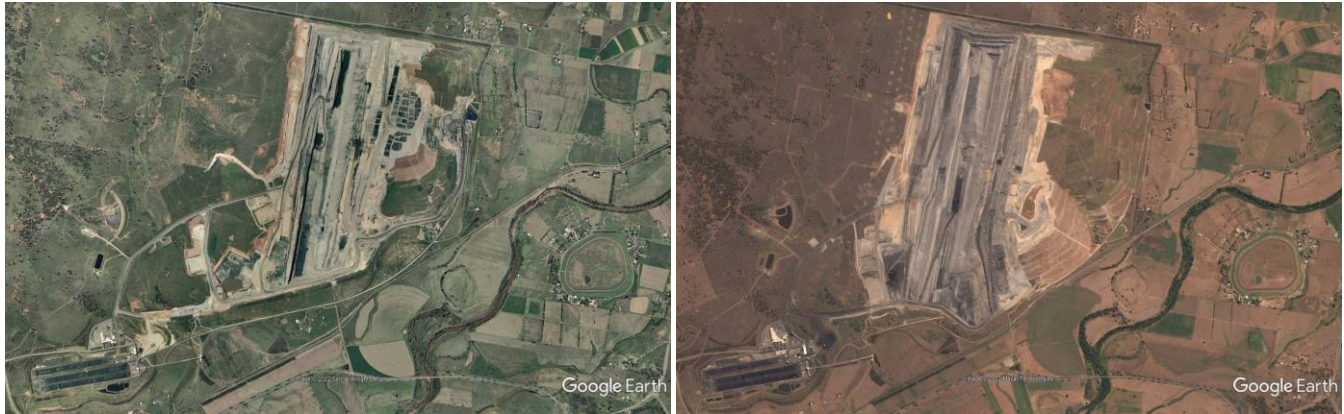
Figure 44 shows a series of Google Earth images going back in time of the open cut Bengalla Coal Mine, located in the Hunter Valley Coalfields of New South Wales, showing the visual bund facing Muswellbrook to the east.

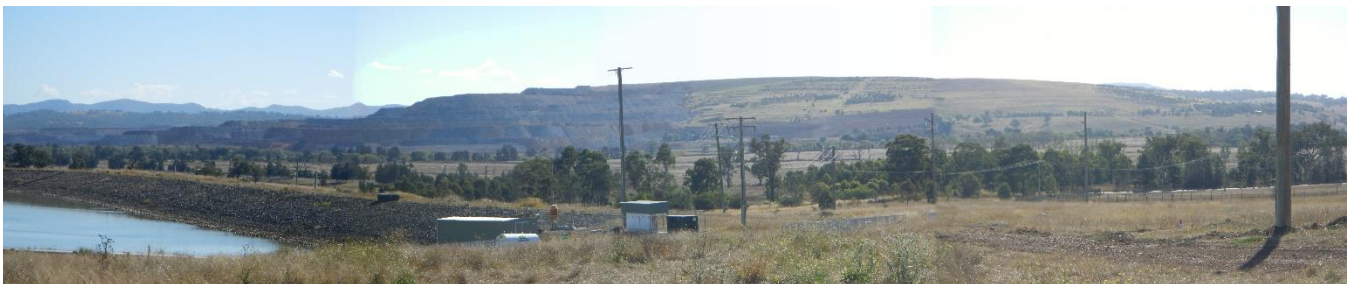
Figure 45: Photographs of Bengalla Coal Mine visual bund facing Muswellbrook taken in September 2016

Figure 45 and Figure 46 show photographs of the Bengalla Coal Mine visual bund facing Muswellbrook taken in September 2016 and February 2017, respectively. In Figure 45, the slope to the west (left) is yet to be reshaped from angle of repose benches and revegetated to meet community expectations.

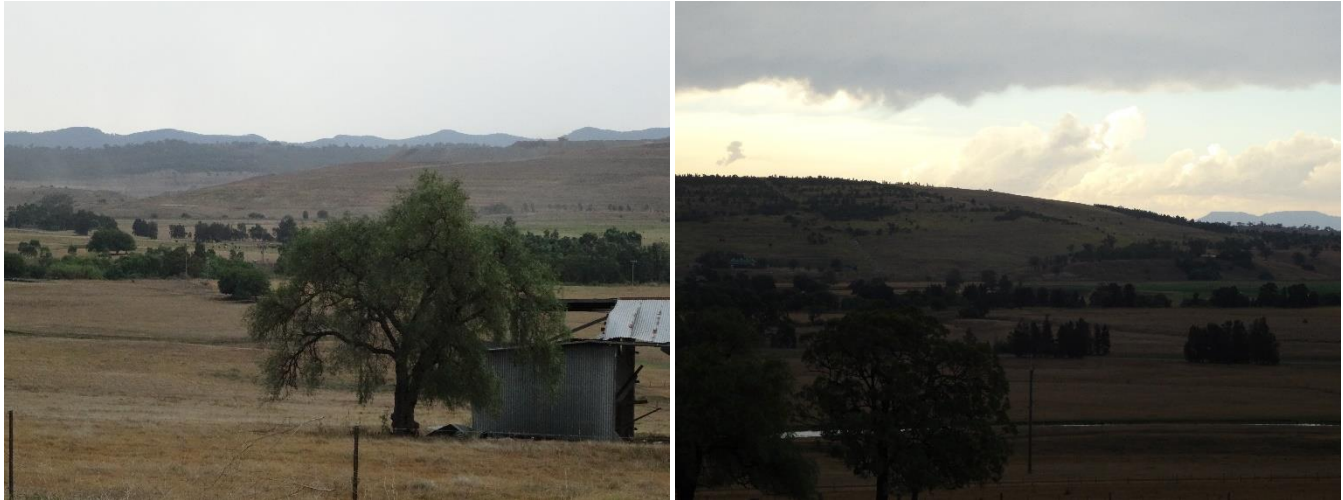
Figure 46: Photographs of Bengalla Coal Mine visual bund facing Muswellbrook taken in February 2017

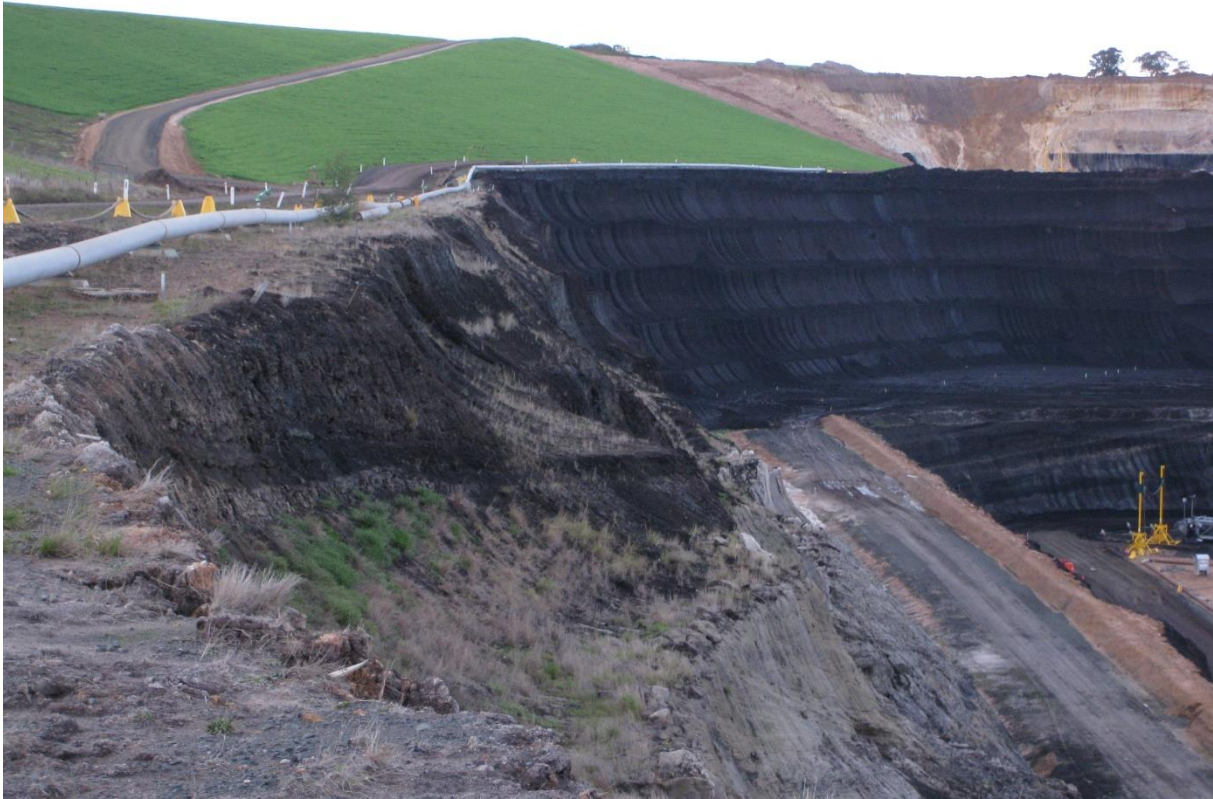
Figure 49: Rehabilitated upper slopes and trial slope rehabilitation of Loy Yang open cut in June 2010

Figure 49 shows rehabilitation and trial rehabilitation of the upper slopes of the Loy Yang open cut in June 2010. Figure 50 shows a view of the rehabilitated super-elevated overburden dump beyond Loy Yang open cut in October 2018.

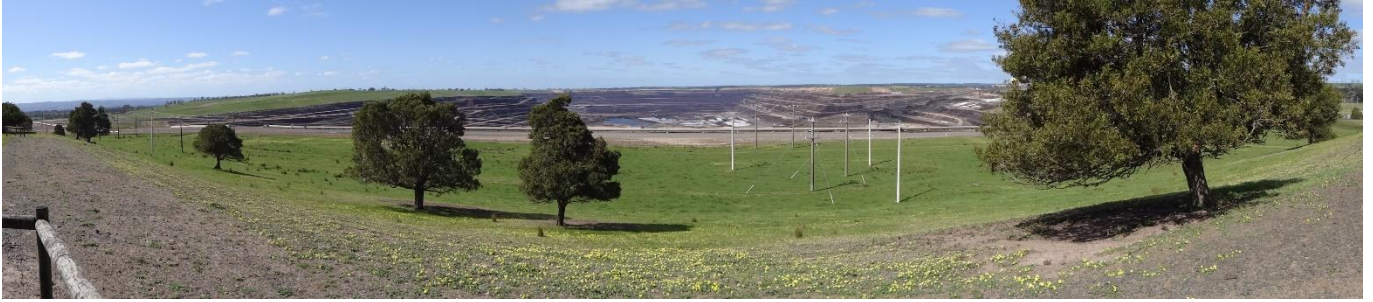
Figure 50: View of rehabilitated overburden dump beyond Loy Yang open cut in October 2018

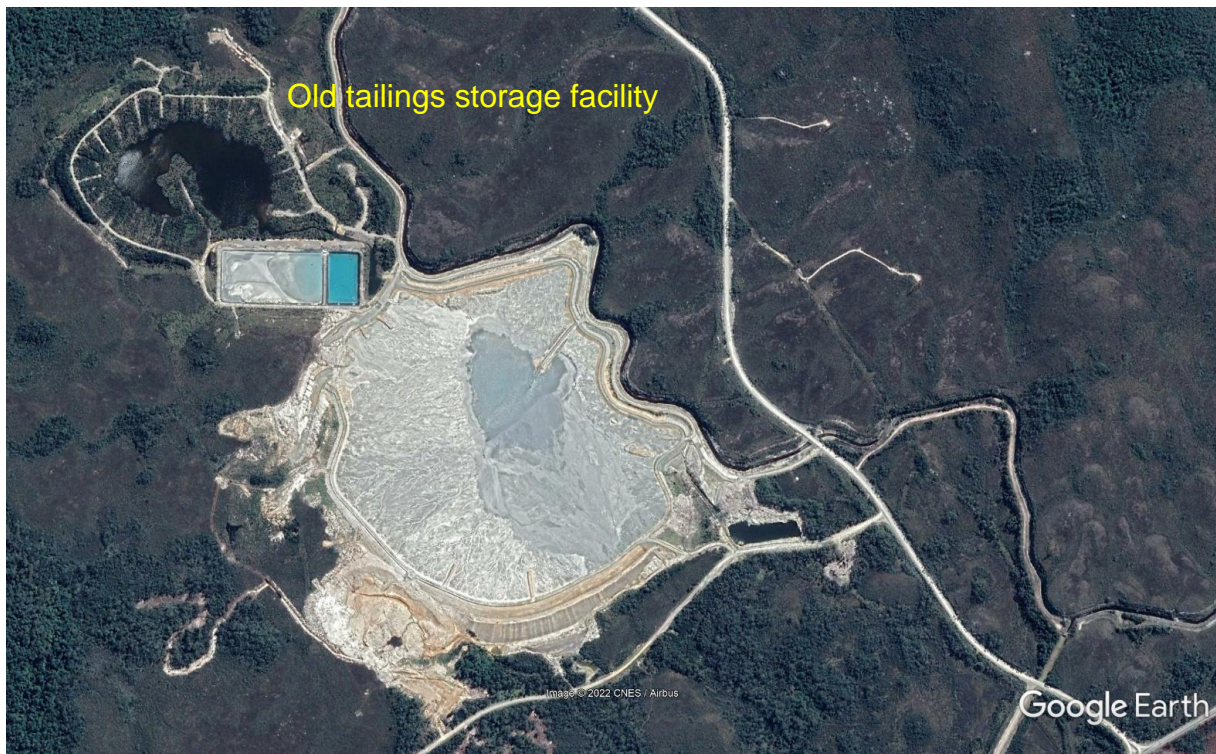
Figure 52: Google Earth images of Henty Gold Mine tailings storage facilities (November 2018)

Figure 52 shows a Google Earth image of the Henty Gold Mine tailings storage facilities in November 2018. The covered old tailings storage facility is in the top left-hand corner of the image.

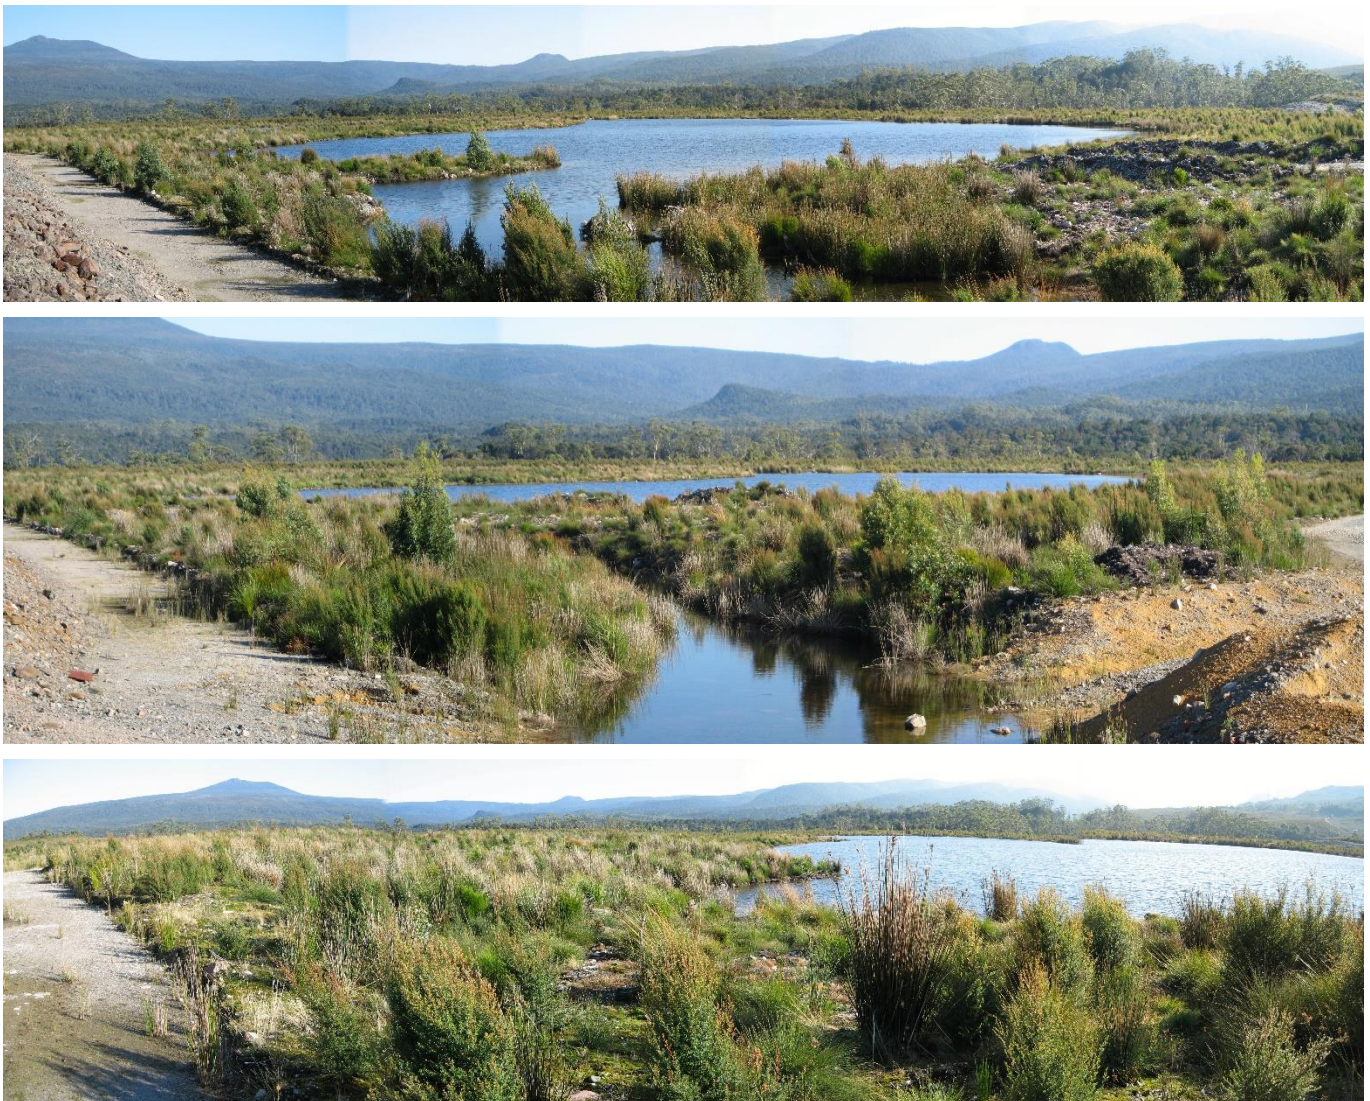
Figure 53: Photographs of peat and water cover over old tailings storage facility at Henty Gold the Google Earth images of Henty Gold Mine tailings storage facilities taken in April 2008

For Henty, Brett (2009) describes a combined peat and water cover over the old tailings storage facility. The concept was to expand the perimeter of the tailings storage facility by reconstructing a natural peat cover, adding to the stability of the tailings dam, and containing a water cover within the interior of the facility. The wet climate of the site ensures that the peat remains saturated, which, together with the water cover, effectively excludes oxygen ingress into the underlying sulfidic tailings, which remain saturated. A spillway was incorporated capable of passing the probable maximum flood, while ensuring that the saturated peat and water cover were maintained. The performance of the cover has been assessed over time to have mitigated acidic seepage from the facility. Photographs of the cover, taken in April 2008, are shown in Figure 53.

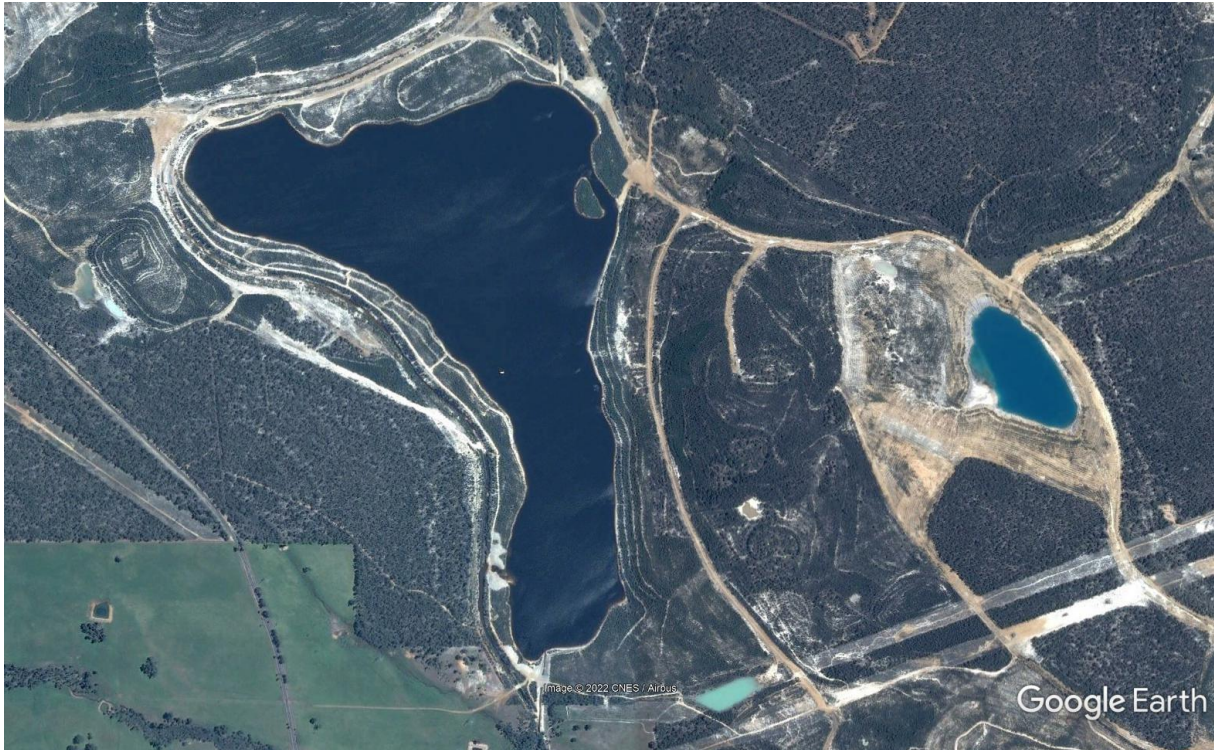
Figure 57: Google Earth images of Collie Coal Mine Lake Kepwari going back in time: (a) January 2022, and (b) October 2013

The Collie Coal Basin, located approximately 160 km south of Perth, is the centre of the coal mining industry in Western Australia (McCullough, 2021). More than 100 years of coal mining around Collie has resulted in 13 significant pit lakes with differing water quality and extent of rehabilitation. All pit lakes are acidic due to moderate acid and metalliferous drainage from the low sulfide spoil and overburden surrounding them. The most significant of the pit lakes is Lake Kepwari, which has been integrated into the Collie River South Branch. Figure 57 shows two Google Earth images of Lake Kepwari over time.

Contoured spoil is seen in Figure 57 (a) to the west and east of Lake Kepwari, which continues to erode into the pit lake. In Figure 57 (b), the western slope has been reprofiled, eliminating the contour banks, in an effort to reduce erosion.

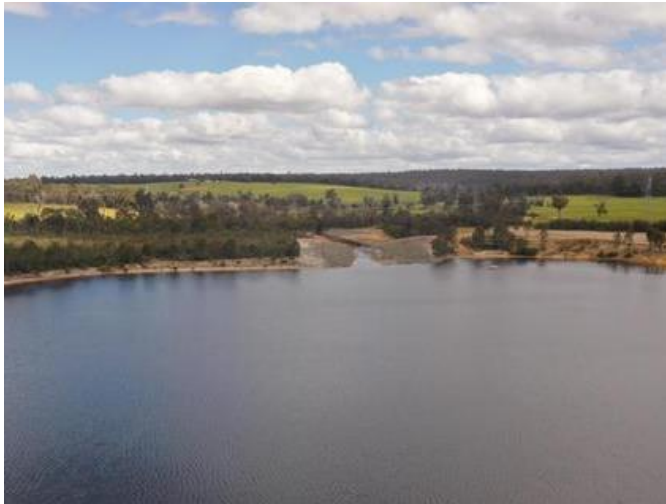
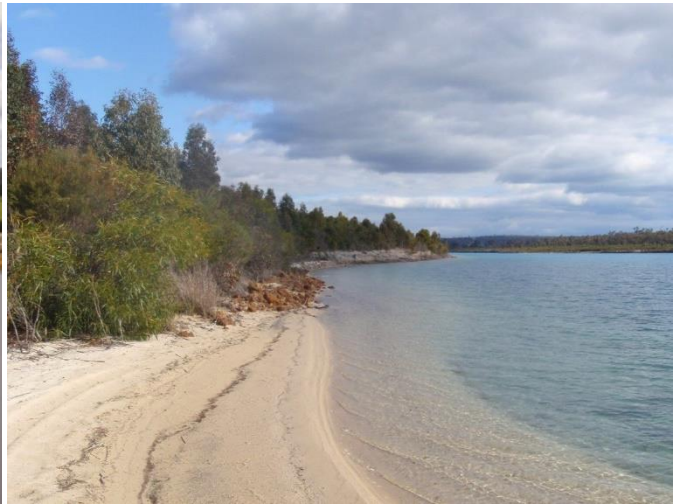
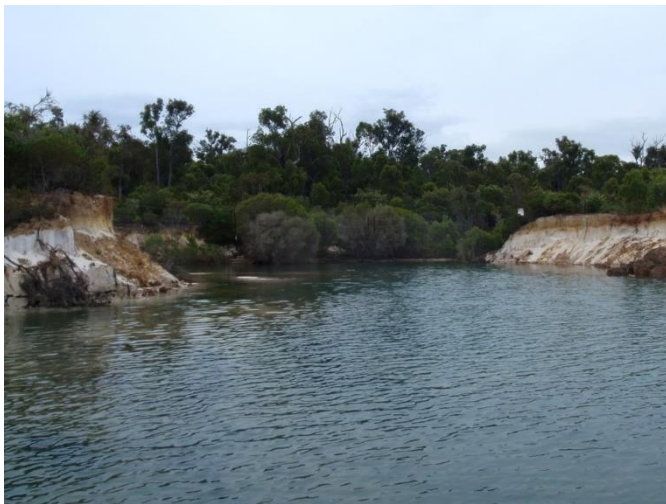
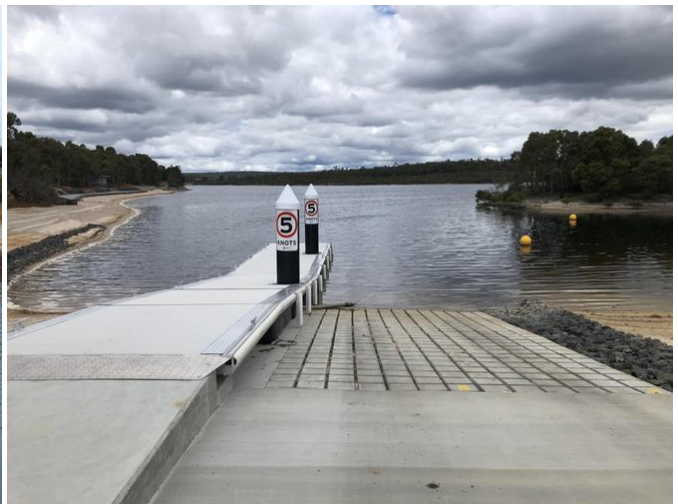
Figure 58: Photographs of Lake Kepwari, showing: (a) outlet spillway, (b) overtopping of input diversion due to heavy rainfall in August 2011, (c) perimeter beach, and (d) boat ramp

To enable coal reserves beneath the original Collie River South Branch to be mined and to fill Lake Kepwari (which was estimated to take 100 years to fill naturally), the South Branch of the Collie River was diverted into Lake Kepwari to the north during the winters from 2002 to 2008, and an outlet spillway to the south controls the lake level (Figure 58 (a)). Although the input of Collie River South Branch water initially raised the pH of Lake Kepwari to above 7, the pH then fell below 4 once river inflows ceased. This low pH and associated elevated concentrations of some metals and metalloids reduced water quality and restricted end use opportunities. However, the lake remained visually spectacular with extremely high transparency due to an absence of phytoplankton, restricted by low phosphorus due to the acidic water (Figure 58 (b)).

Heavy rainfall in August 2011 led to the overtopping and erosion of the diversion channel into Lake Kepwari (Figure 58 (c)). This unintentional flushing had the effect of substantially improving the water quality and

ecosystem values of the lake, raising the pH from about 4 to about 7.5 and lowering the electrical conductivity from about 3,200 to about 2,200 mS/cm, by late 2018. This indicated that maintaining the lake as a flow-through system would likely be a sustainable closure strategy, and led in November 2018 to the relinquishment of Lake Kepwari. Figure 58 (d) shows the boat ramp constructed to enable recreational use of Lake Kepwari.

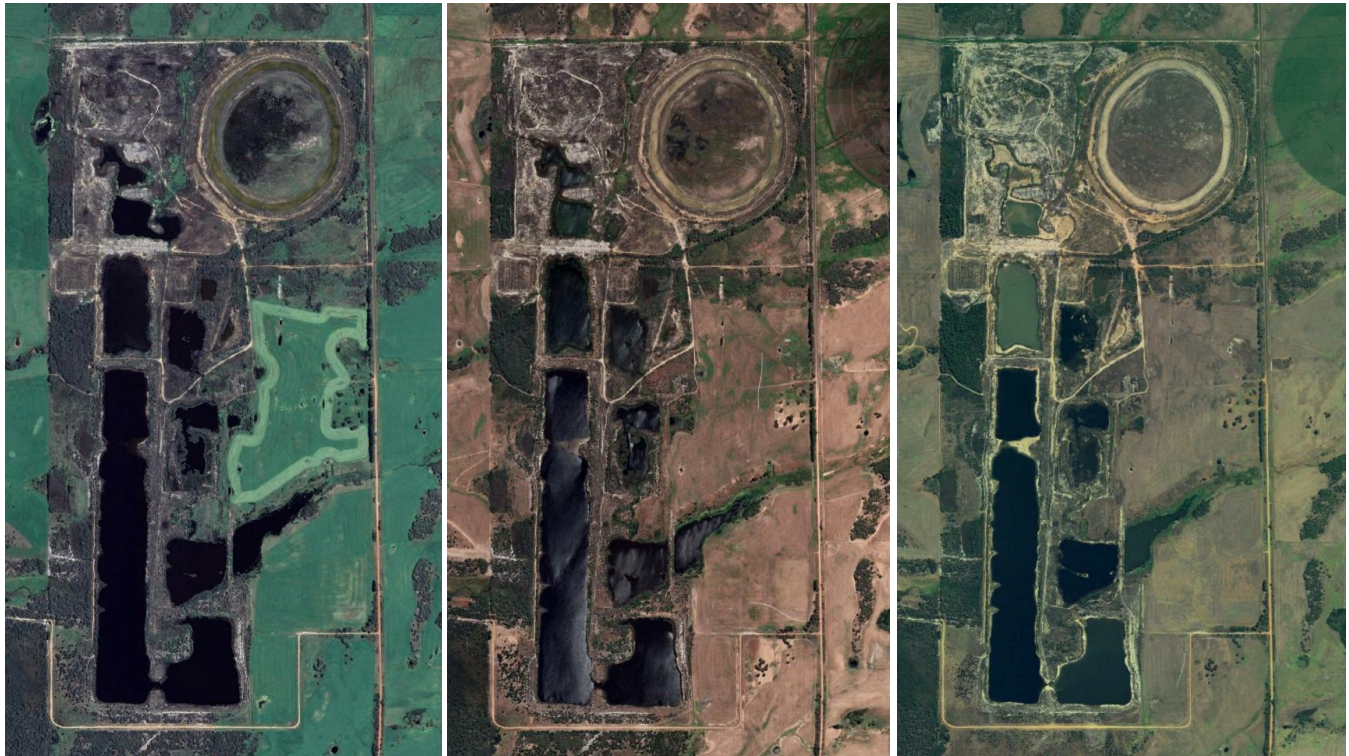
Figure 59: Google Earth images of Beenup Minerals Sands Mine going back in time: (a) October 2018, (b) December 2016, and (c) February 2011

Figure 59 shows a series of Google Earth images going back in time of the rehabilitation of the Beenup Mineral Sands Mine, located in South-West Western Australia, in which the mining voids remained as pit lakes.

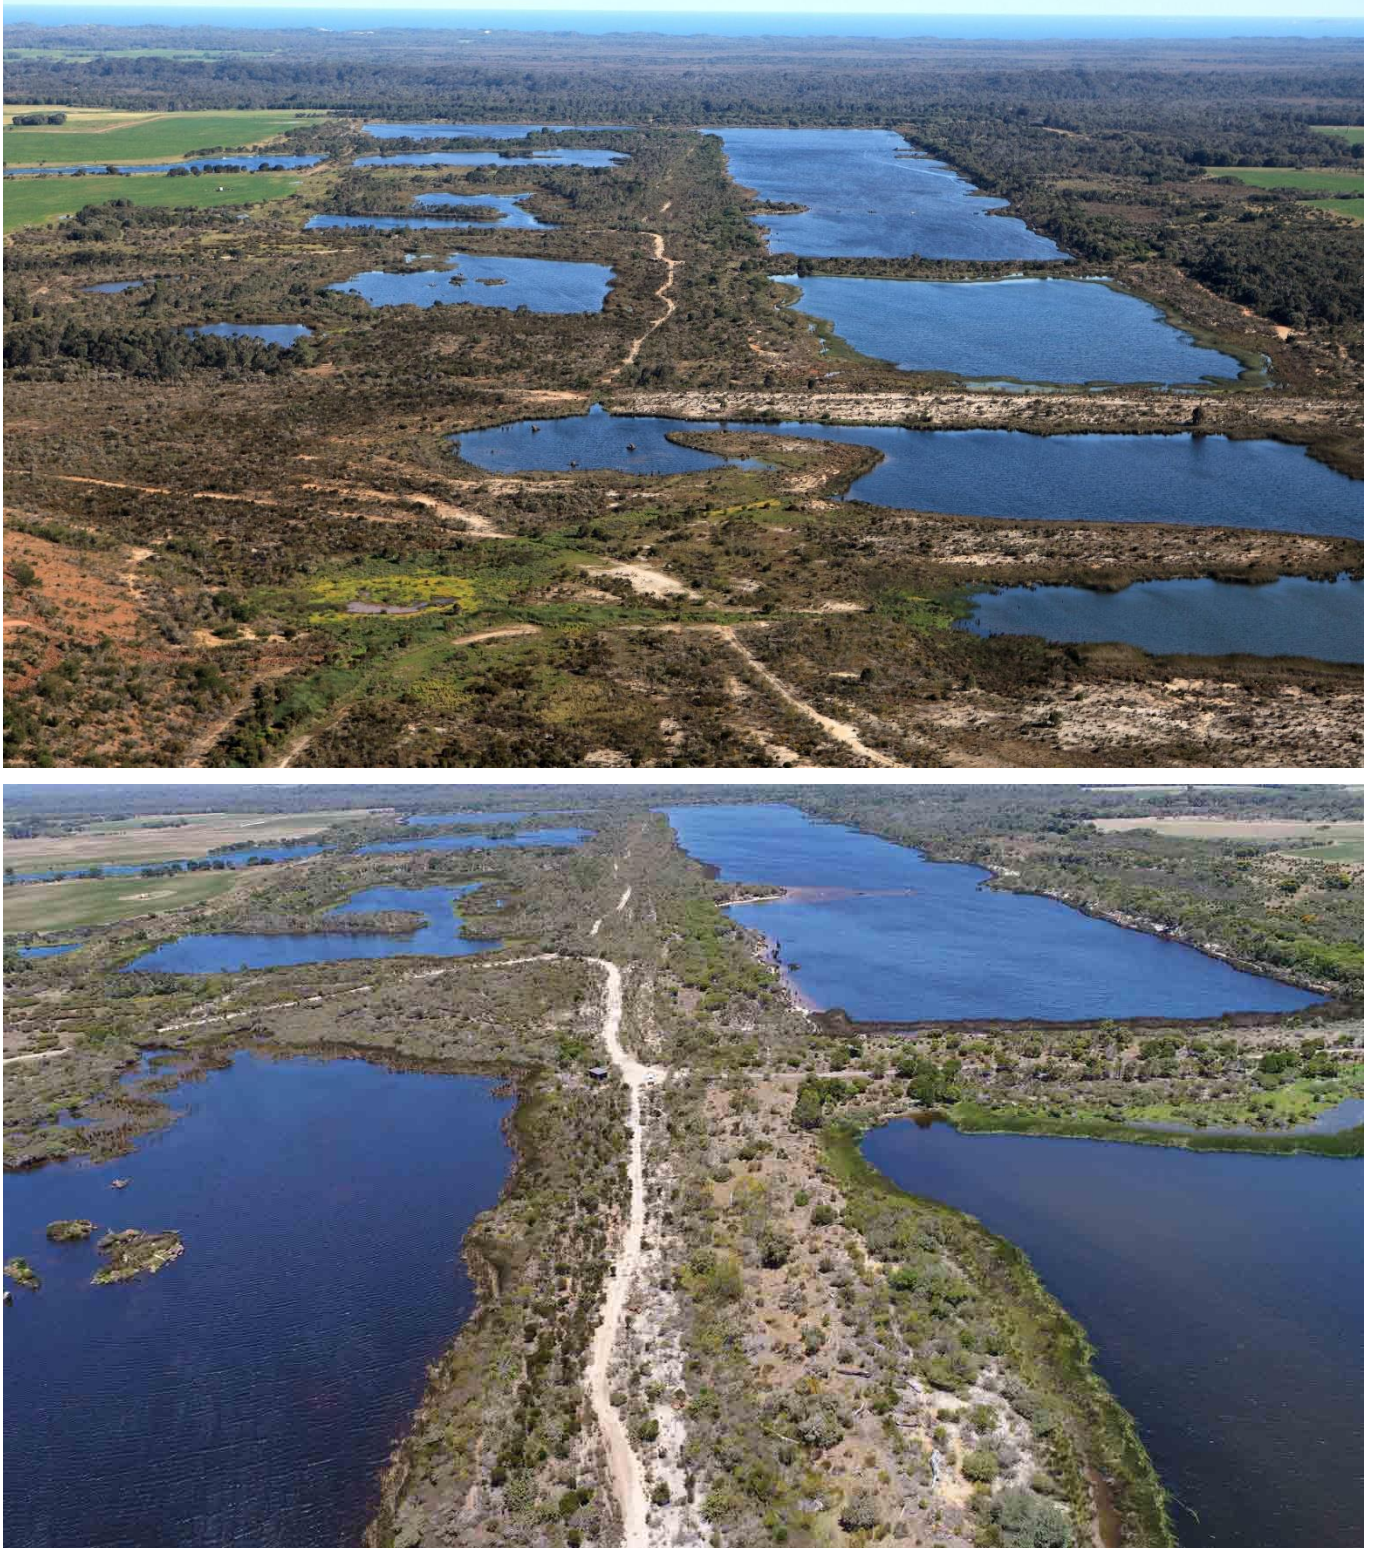
Figure 61: Completed rehabilitation at Beenup Mineral Sands Mine

Rehabilitation of the site was largely completed in 2018 (Figure 61), although monitoring and inspection of spillways and other engineered structures continues. Dredge pond water was treated and used for irrigation. Pyrite soils were neutralisation and permanently saturated. Surface water drainage was reinstated to reflect the baseline qualities of nearby water systems. The resulting wetlands, established in collaboration with the Western Australian Botanic Gardens and Parks Authority, are now host to four declared rare flora species.
